CERTIFICATION REPORT

Alliance for Water Stewardship (AWS)

Audit Number: AO-001650

Site: **PMFTC Inc., Marikina Plant**

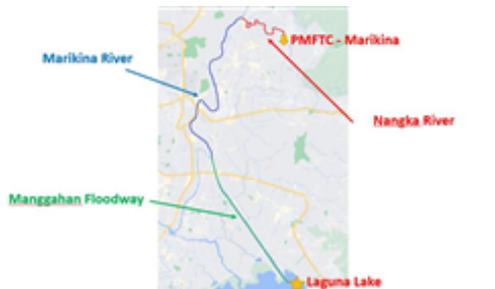
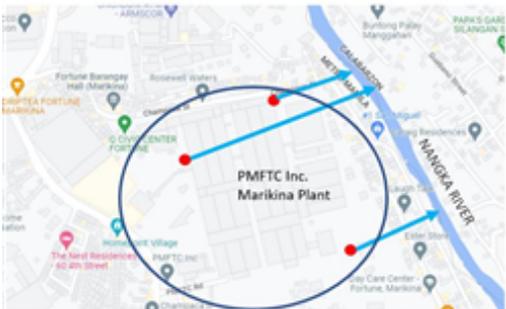
1.1.1 D 2025 Discharge Point Map of PMFTC Marikina and ultimate receiving water bodies2.jpg

The site's ultimate water discharge point is Laguna Lake. There are at least three discharge points, release water into the nearby Nangka River. Rainwater, when collected in storm drains, flows into a creek connected to the Nangka River, which in turn drains into the Marikina River. From there, it passes through the Manggahan Floodway and eventually empties into Laguna Lake.

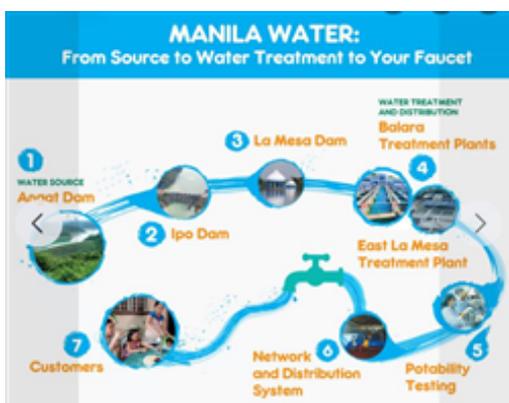
1.1.1 C Manila Water sourcing points_PMFTC Marikina.jpg

The site is located within the Angat Watershed, with the Angat Dam as its primary water source. The dam is approximately 65.6 km away, which is about a 2-hour and 37-minute drive. This watershed supplies water to Manila Water, the site's water provider. Water from Angat Dam flows through Ipo Dam and La Mesa Dam, then undergoes treatment at the Balara Treatment Plants. After potability testing, it is distributed to customers in Marikina.

Angat Dam supplies 97% of Mega Manila's water, including the site. Of this, 60% goes to the La Mesa Treatment Plants, while the remaining 40% is delivered 6.8 km downstream to the Balara Treatment Plant. Manila Water continues to meet the domestic demand in the Marikina River Basin despite its growing customer base; even the 1,600 MLD allocation from Angat has remained unchanged since 1997. Manila Water relies heavily on surface water, accounting for 87%, with only around 12% drawn from underground sources, ensuring the sustainability of the aquifers.

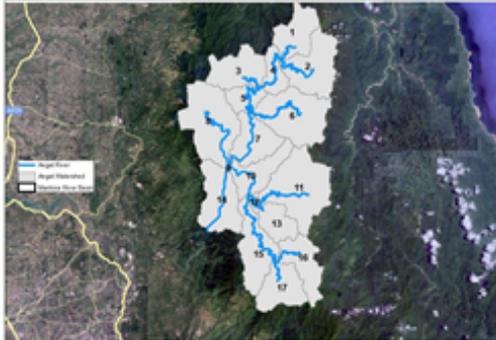
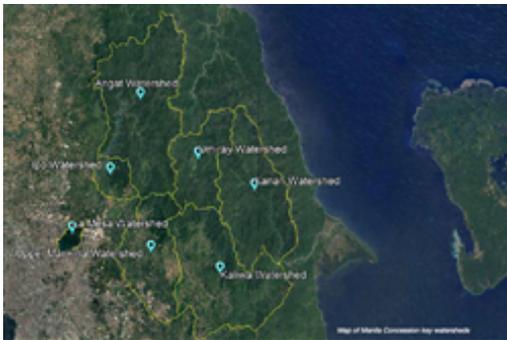
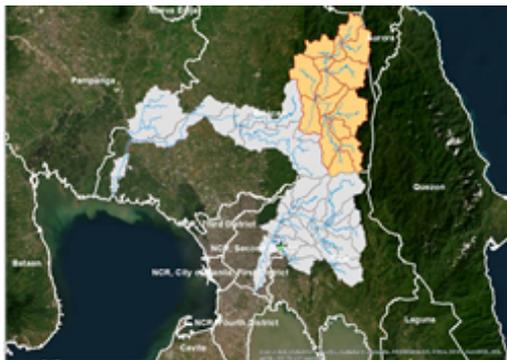
Angat Watershed & Marikina Watershed.png

According to the Angat River Basin Hydrologic Modelling Study for PMFTC Marikina Corporate Water Strategy, the Angat River Basin covers 54,643.6 hectares (546.43 sq km) with 17 subbasins in the municipalities of Dona Remedios and Norzagaray, Bulacan. The Angat River flows from the Sierra Madre Mountains to Manila Bay and has three dams: Angat, Ipo, and Bustos. The Upper Angat River Basin ranges in elevation from 163 m to 1,255 m above sea level, and the river runs 46 km from upstream to the Angat Dam.

Comment There are no significant changes with the Angat Watershed that include the Marikina Watershed, where the site is specifically located.

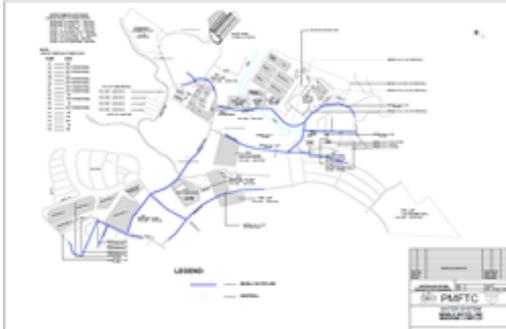
1.1.1 C.png

disposal, while the liquid effluent undergoes a rapid sand filtration process. The recovered water is then collected in a wet scrubber holding tank connected to the DIET area. The two drains ultimately discharge into the Laguna Lake, following this path: storm drains → creek → Nangka River → Marikina River → Manggahan Floodway → Laguna Lake.
