CERTIFICATION REPORT

Alliance for Water Stewardship (AWS)

Audit Number: AO-001810

Site: **EES SA de CV**

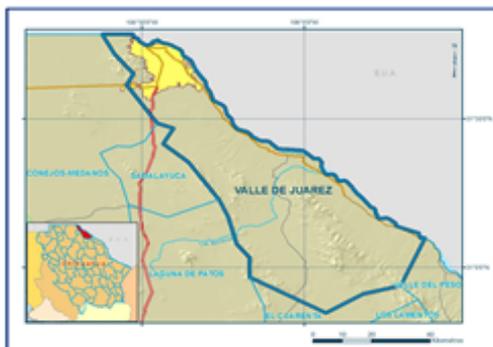
Acuífero Valle de Juarez.png

VALLE DE JUÁREZ AQUIFER

- The Site is in the Valle de Juárez aquifer, defined with the code 0833 by CONAGUA, located in the northern portion of the state of Chihuahua, it covers an area of 3,386 km².

- The Valle de Juárez aquifer is bordered to the north and east by the international border between Mexico and the US, to the west by the Conejos-Médanos and Samalayuca aquifers, and to the south by the Laguna de Patos, El Cuarenta, and Valle del Peso aquifers.

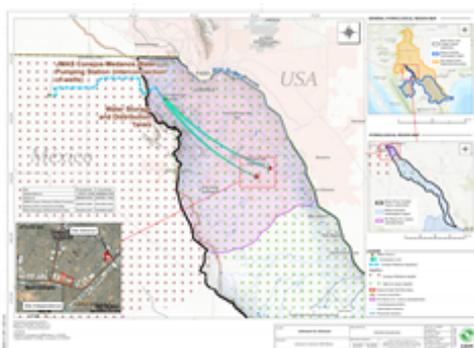
2._Water_sources.jpg

Water service provided JMAS, Conejos Medanos pumping station, interconnection of wells (water storage and distribution tanks).

Except for drinking water and treated water for irrigation in pipes, the Site gets almost all its water from the municipal water department JMAS (Municipal Water and Sanitation Board, by its acronym in Spanish), which goes from the JMAS intake to some storage tanks and then to a treatment on-site.

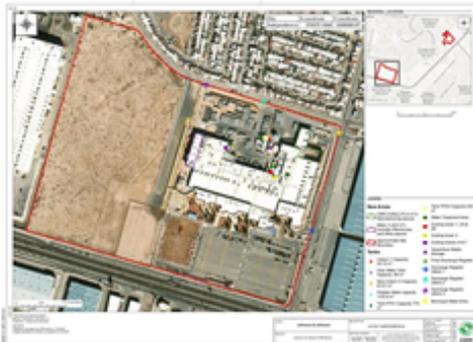
1. Layout Independencia A.jpg

D. Describe the water-related infrastructure:

1. Any water sources on the site (wells, connection to the municipal water supply, etc.): connection to the municipal water supply,

6. Cooling towers: Cooling towers, Boiler Pack. Cooling towers loop at roof.

7. Rainwater harvesting infrastructure: Yes

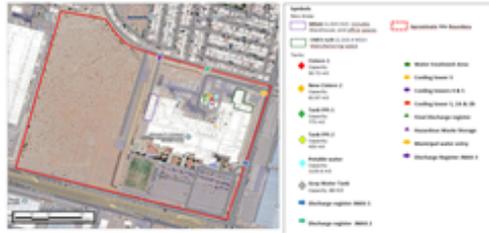
Uso del agua en las instalaciones.png

Uso del agua en las instalaciones
