CERTIFICATION REPORT

Alliance for Water Stewardship (AWS)

Audit Number: AO-001695

Site: **Nestle Waters Eco de los Andes S.A. AR PL NW Tunuyan-Mendoza**

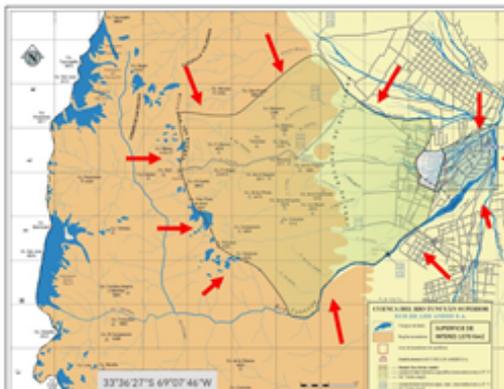
1.1.1 mapa cuenca formato imagen referenciado.JPG

Name of the Basin:

- The name of the basin is the Upper Tunuyán River Sub-Basin (Sub cuenca del río Tunuyán superior).

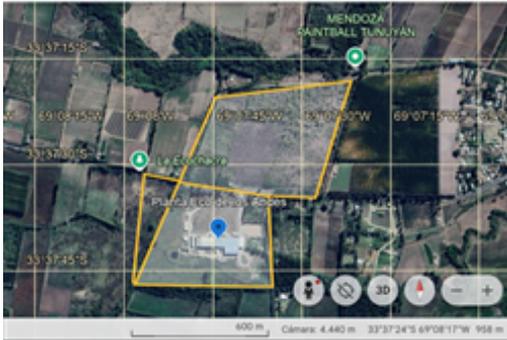
Plano con Sitio con escala y Norte -mapa earth.JPG

Brief description of the site:

The site has 81 direct employees. The covered area is 1,200 m². The land area is 54 ha.

The building infrastructure consists of: 1 office building, 1 production building + warehouse + offices, 1 building with a medical office and cafeteria, and 1 locker room building + offices.

- Site boundaries: included in the file "Site Plan with Scale and North - Earth Map.jpg".
- Water infrastructure: included in the file "ID0364PI0001 (Water Treatment Plant PID Diagram) REVI" with the water pipe network, and file "ID0692PI0001 (Effluent Plant PID Diagram) REVD" with the effluent network.
- Any water source supplying the site: N/A
- Water service provider: N/A
- Discharge points and wastewater service provider: N/A
- Watershed(s): The file "1.1.1 watershed map, referenced image format.jpg" is included, detailing the watershed declared for the site. This corresponds to the hydroecological protected area defined by Resolution 360/02 of Mendoza and the watershed, adding nearby urban centers, such as Tunuyán.
