Alliance for Water Stewardship Assessment Report

Prepared for UNION DE BANANEROS ECUATORIANOS S.A.- UBESA.

Prepared by: SGS

Date: 20.01.2022

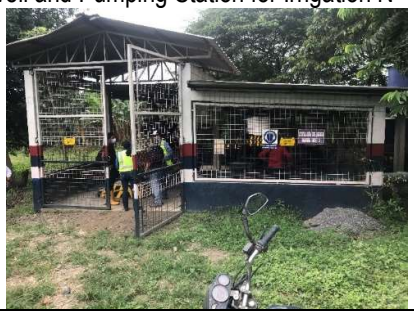
<table><tr><th colspan="2">FINCA MARÍA JOSE; LOLA, ISABEL MARÍA</th></tr><tr><td>Well and Pumping Station for Irrigation N ° 2
  </td><td>Pumping system and flow distribution
  </td></tr></table>

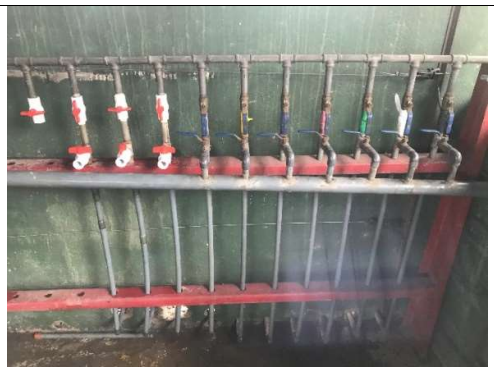
Flow and Distribution Measurement System
