CERTIFICATION REPORT

Alliance for Water Stewardship (AWS)

Site: **Haleon - Buenos Aires, Argentina**

Audited Service(s): AWS Standard v2.0 (2019)

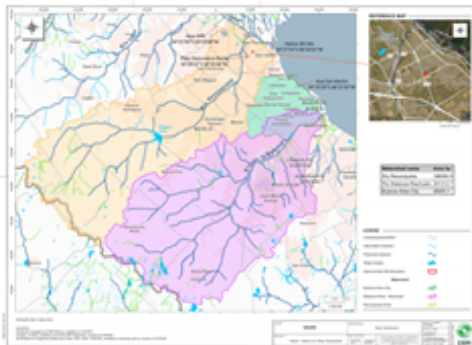
Attached catchment map (Ríos Reconquista en Río Luján/Paraná de las Palmas).
Map04_SitesCatchments_AWS_BA.jpg

Comment Uploaded and attached a main picture of the catchment (aquifer picture is not available).
Other two supporting pictures are also attached.

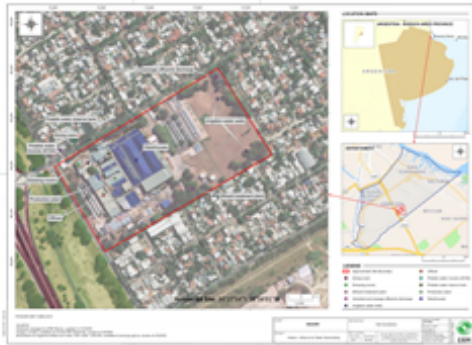
Map01_SiteBoundaries_WaterInfra_AWS_BA.jpg

Comment A georeferenced map showing the site boundaries is attached.
