# CERTIFICATION REPORT

## Alliance for Water Stewardship (AWS)

Site: **Coca Cola FEMSA - Planta Alcorta**

Audited Service(s): AWS Standard v2.0 (2019)

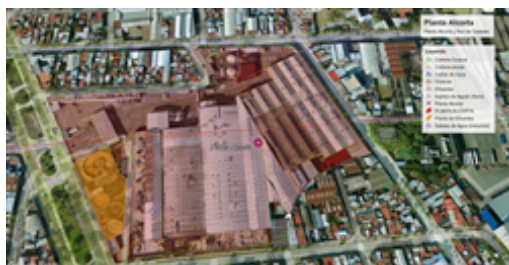
mapa cañerías y salidas planta alcorta.jpg

Bicentennial Treatment Plant of AySA S.A, whose treated effluent is discharged into the Río de la Plata. Rainwater is discharged into the stormwater network of the Government of the City of Buenos Aires, which is connected to the Ochoa-Elias enclosed basin.
