# Alliance for Water Stewardship Assessment Report Prepared for Nestlé Waters Herrera del Duque (AWS-000391)

Prepared by: SGS SGS Ref.: 02-958-296640 Version: 1 Date: 3<sup>rd</sup> March 2022

REFERENCE	02-958-296640				
CERTIFICATE NUMBER	SGS2022_AWS0005				
REPORT TITLE	ALLIANCE FOR WATER STEWARDSHIP ASSESSMENT REPORT				
DATE SUBMITTED:	3rd March 2022				
CLIENT:	NESTLÉ ESPAÑA S.A. NESTLE WATERS HERRERA DEL DUQUE Finca las Navas 06670 Herrera del Duque (Badajoz)				
PREPARED BY:	Paula Gómez Geras C/ de los Abetos, nº1, 2ª planta 47008, Valladolid, Spain. Tel: +34 983 345 703 E-mail: paula.gomezgeras@sgs.com				
SIGNED:	Paula Gómez Signes:				
TECHNICAL SIGNATORY	Jerónimo Casas Signed:				
STATUS	FINAL				
NOTICE	This document is issued by SGS under its General Conditions of Service accessible at <u>http://www.sgs.com/terms_and_conditions.htm</u> . Attention is drawn to the limitation of liability, indemnification and jurisdiction issues defined therein. Any holder of this document is advised that information contained hereon reflects SGS's findings at the time of its intervention only and within the limits of Client's instructions, if any. SGS's sole responsibility is to its C

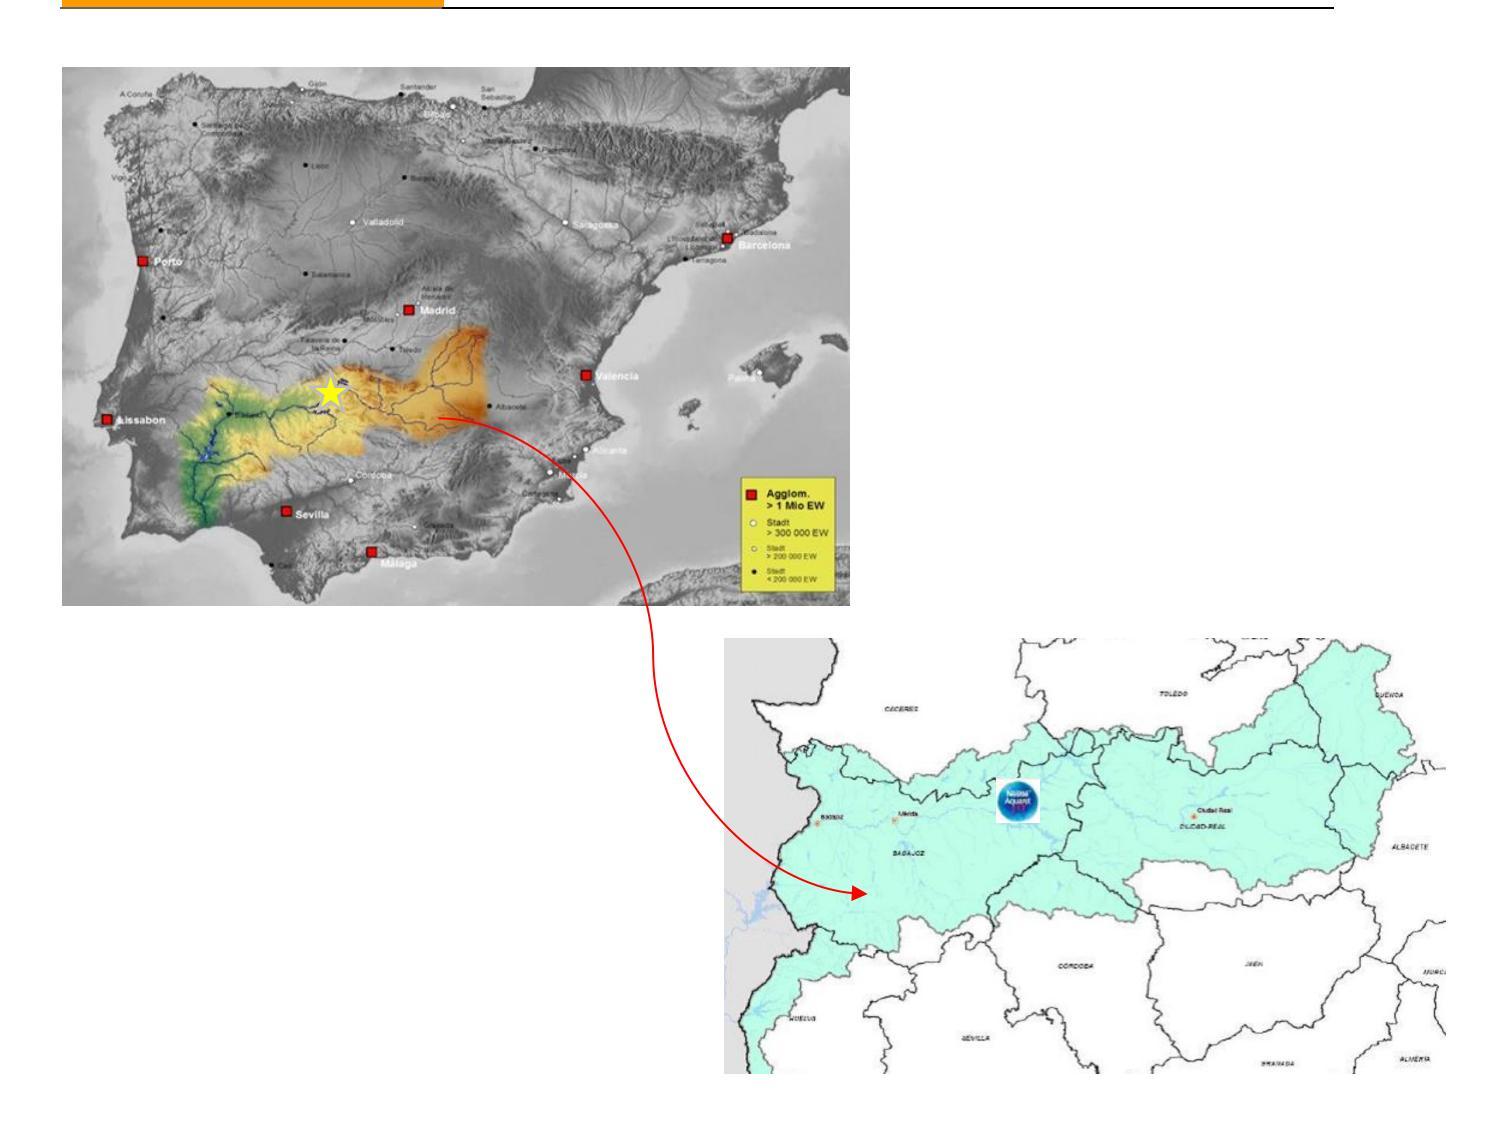
Figure 3:Territorial scope of the Guadiana Basin

The territorial scope of the hydrographic demarcation is the Guadiana Basin (Code 040). The demarcation limits with the Tajo Basin to the North, Júcar Basin to the East and Guadalquivir Basin and area of the rivers Tinto, Odiel and Piedras to the South, being the Spanish surface of 55,528 km<sup>2</sup>.

The hydrography of the Guadiana Basin is constituted by the internal drainage system that are made up by Cigüela, Záncara, Bañuelos y Bullaque rivers on the right side of the Guadiana, and Zújar, Guadámez, Córcoles, Azuer and Jabalón on the left side.

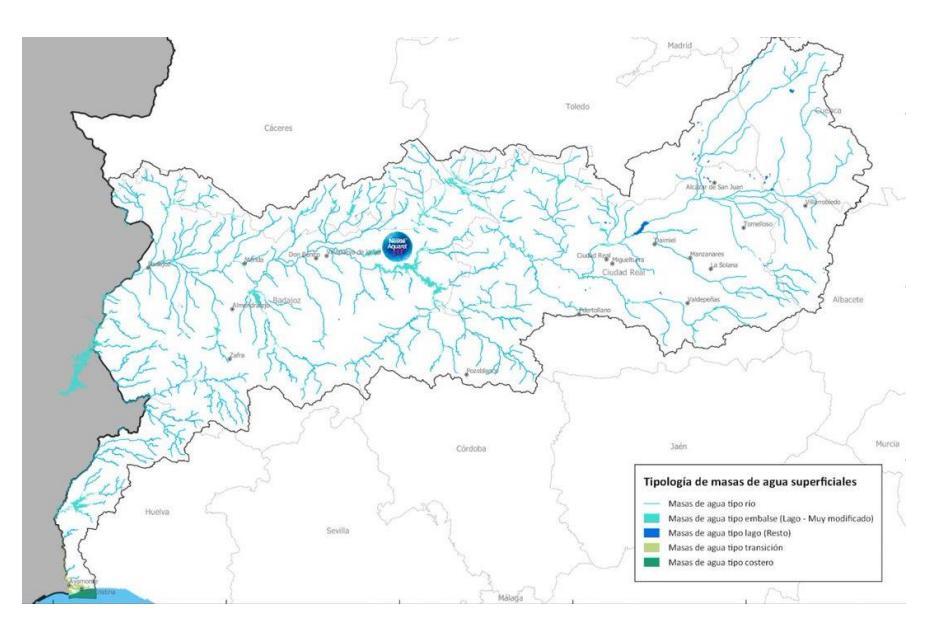
Figure 4: Surface masses of the Guadiana Basin (IGME)

The surface water masses can be classified according to their category or their nature. These masses are grouped depending on the hydraulic infrastructure and water use regulations in management systems that take advantage of natural water resources and, according to their quality, configure the volume of available resources in the basin. Taking part of the Guadiana Basin are more than 20 groundwater masses which area represents 22,484 km<sup>2</sup> approximately.

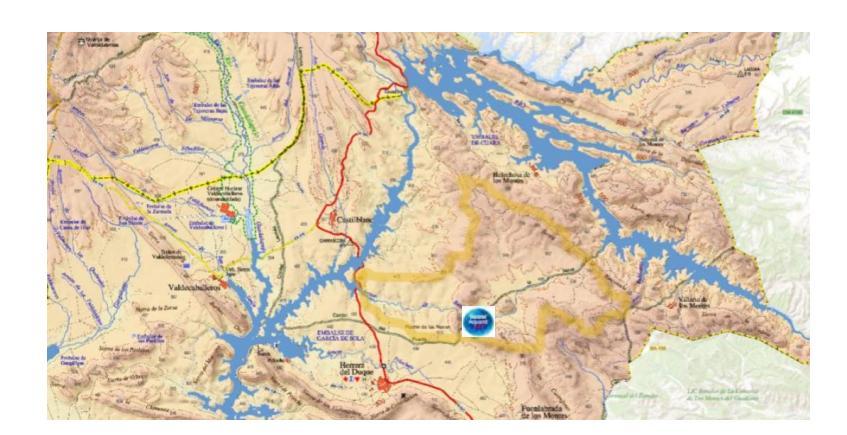
Figure 6: Territorial scope of the Benazaire Basin

Taking part of this hydrographic basin, the bottling plant Nestlé Water Herrera del Duque is located in the basin of the Benazaire river (code ES040MSPF000119920), being a tributary of Guadiana river.

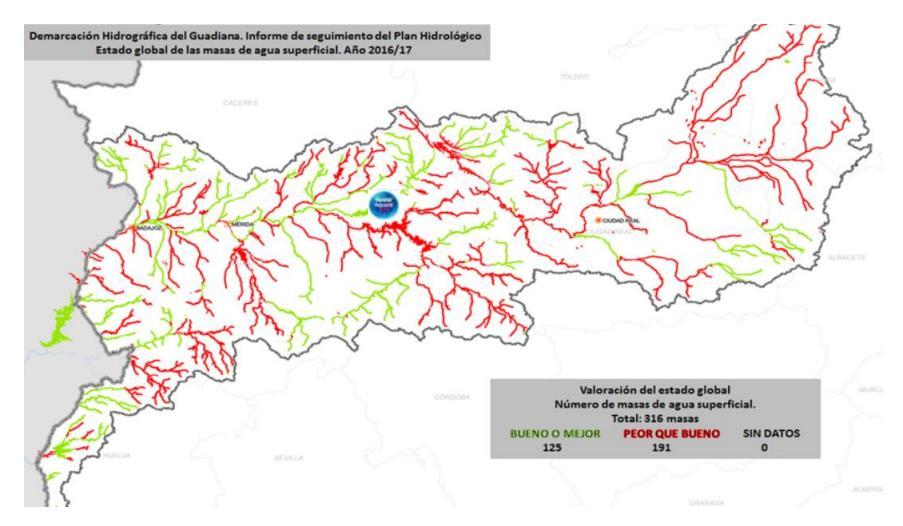
Figure 7: Nestlé Waters Herrera del Duque location in a map of the state of the surface water masses

The assessment of the overall state of surface water is determined by quantitative or chemical status of groundwater bodies and 125 masses of water have a good quality where Benazaire river basin is located.

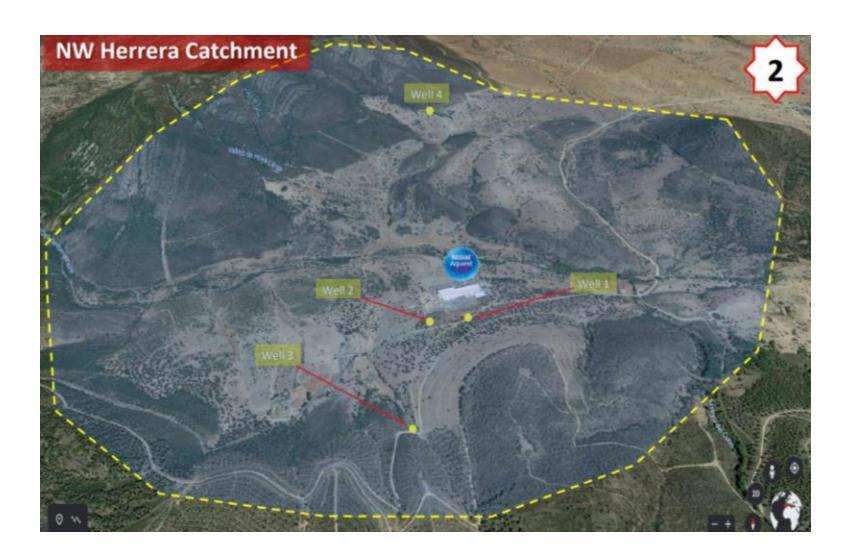
Figure 10: Extension of the Nestlé Waters Herrera del Duque Catchment

Within the Guadiana Basin, Nestlé Waters in Herrera del Duque is surrounded by groundwater resources as water well Encinas 1, Encinas 2 and Jaras 3 used by their production. As well as Jaras 4 located on the boundary but it is not used in their production.

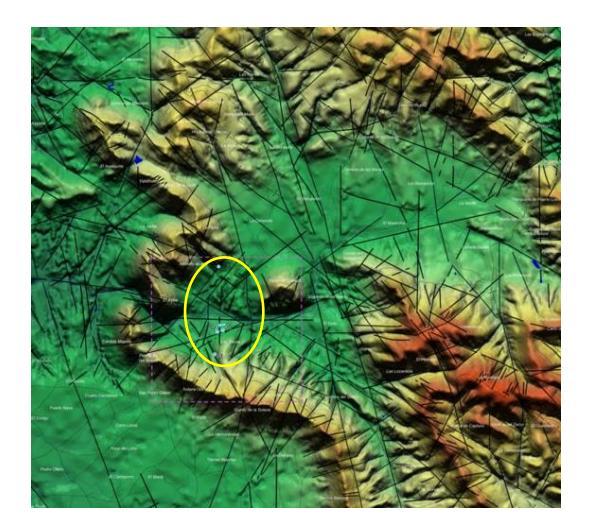
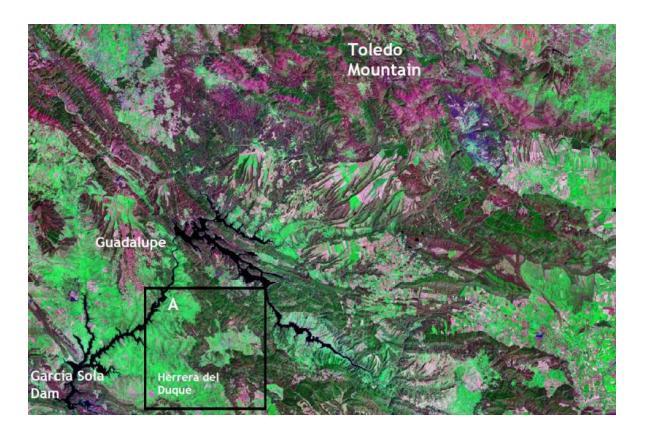
Figure 11: Geomorphological scheme of the Nestlé Waters Herrera del Duque location

Concerning geomorphological units, four distinct sectors were identified in the surroundings of the Herrera del Duque region:

- 1. planation surface, is an erosive planation that surrounds quartzitic ridges and has 400m elevation
- 2. quartzitic ridges (750 m elevation) form prominent hills related with differential erosional processes and quaternary fluvial incision
- Dehesa de las Navas depression, is marked by a flat surface (450-500m) surrounded by quartzitic ridges and an isolated relief, near the bottling plant, called Cerro del Cabezo (678m)
- 4. "Raña" platforms, are fluvial deposits located close to the base of the quartzitic hills.

The geomorphology of the studied area is controlled by the steep outcrops of the Armorican quartzite, reaching elevations of about 750m, decreasing gradually from SE to NW (elevation of 700m at Puerto de las Navas). The Arroyo Benazaire, is the main river of the area, approximately in the center of the Dehesa de las Navas synclinorium, flowing generally E-W.

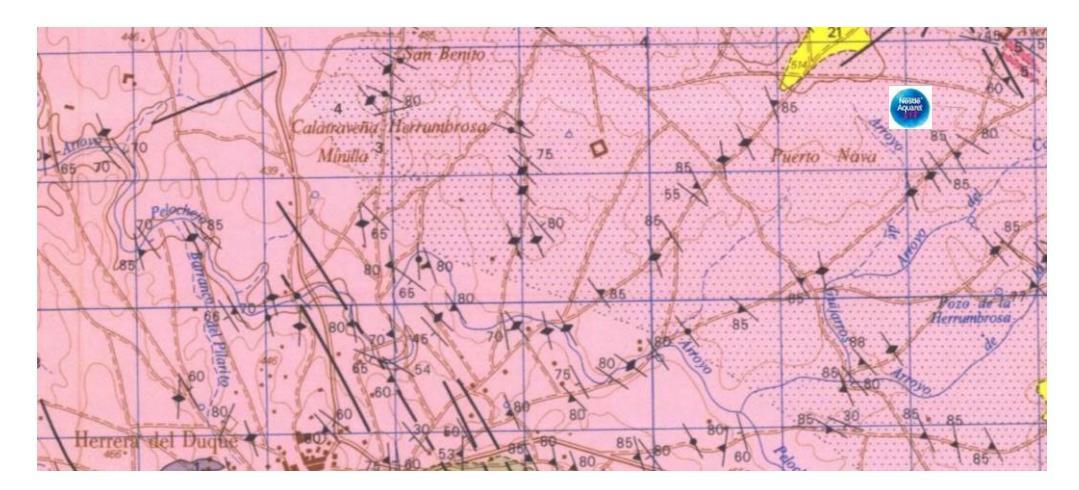
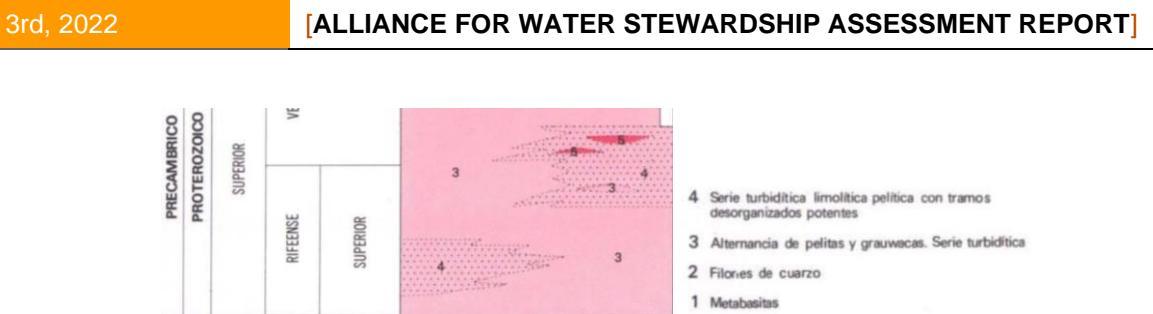
Figure 13: Geological scheme of Nestlé Waters Herrera del Duque

The studied area is located on the Middle-Upper Paleozoic metasedimentary sequences of the southeastern Central-Iberian Zone mainly composed of black shales, siltstones, quartzites, whereas sedimentary cover rocks are dominated by Upper Tertiary siliciclastic conglomerates of fluvial deposits and alluvium deposits.

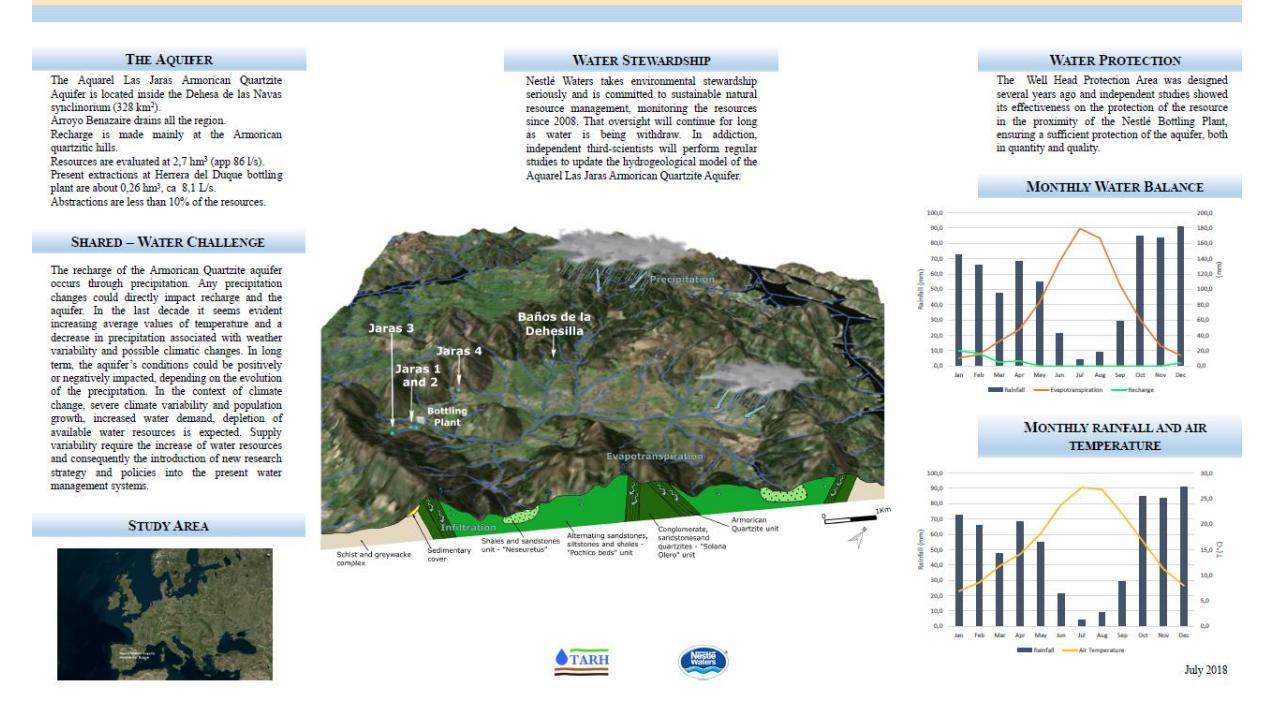
Figure 15: Water Balance in the Benazaire basin

With regards to the water balance of the Benazaire Basin, it is important to note that the Hydrologic basin (surface considered) area is 327.5 km<sup>2</sup>.

The average precipitation is 633 mm/year (The evapotranspiration 470 mm/year, direct runoff and infiltration 162 mm/year). Hence, the natural recharge is 2.7 hm<sup>3</sup>/year.

The authorized license extractions are 788,400 m<sup>3</sup>/year (withdrawal in 2020 is 223,000 m<sup>3</sup>).

With this input and outputs, the total water balance is 52.2 mm/year.

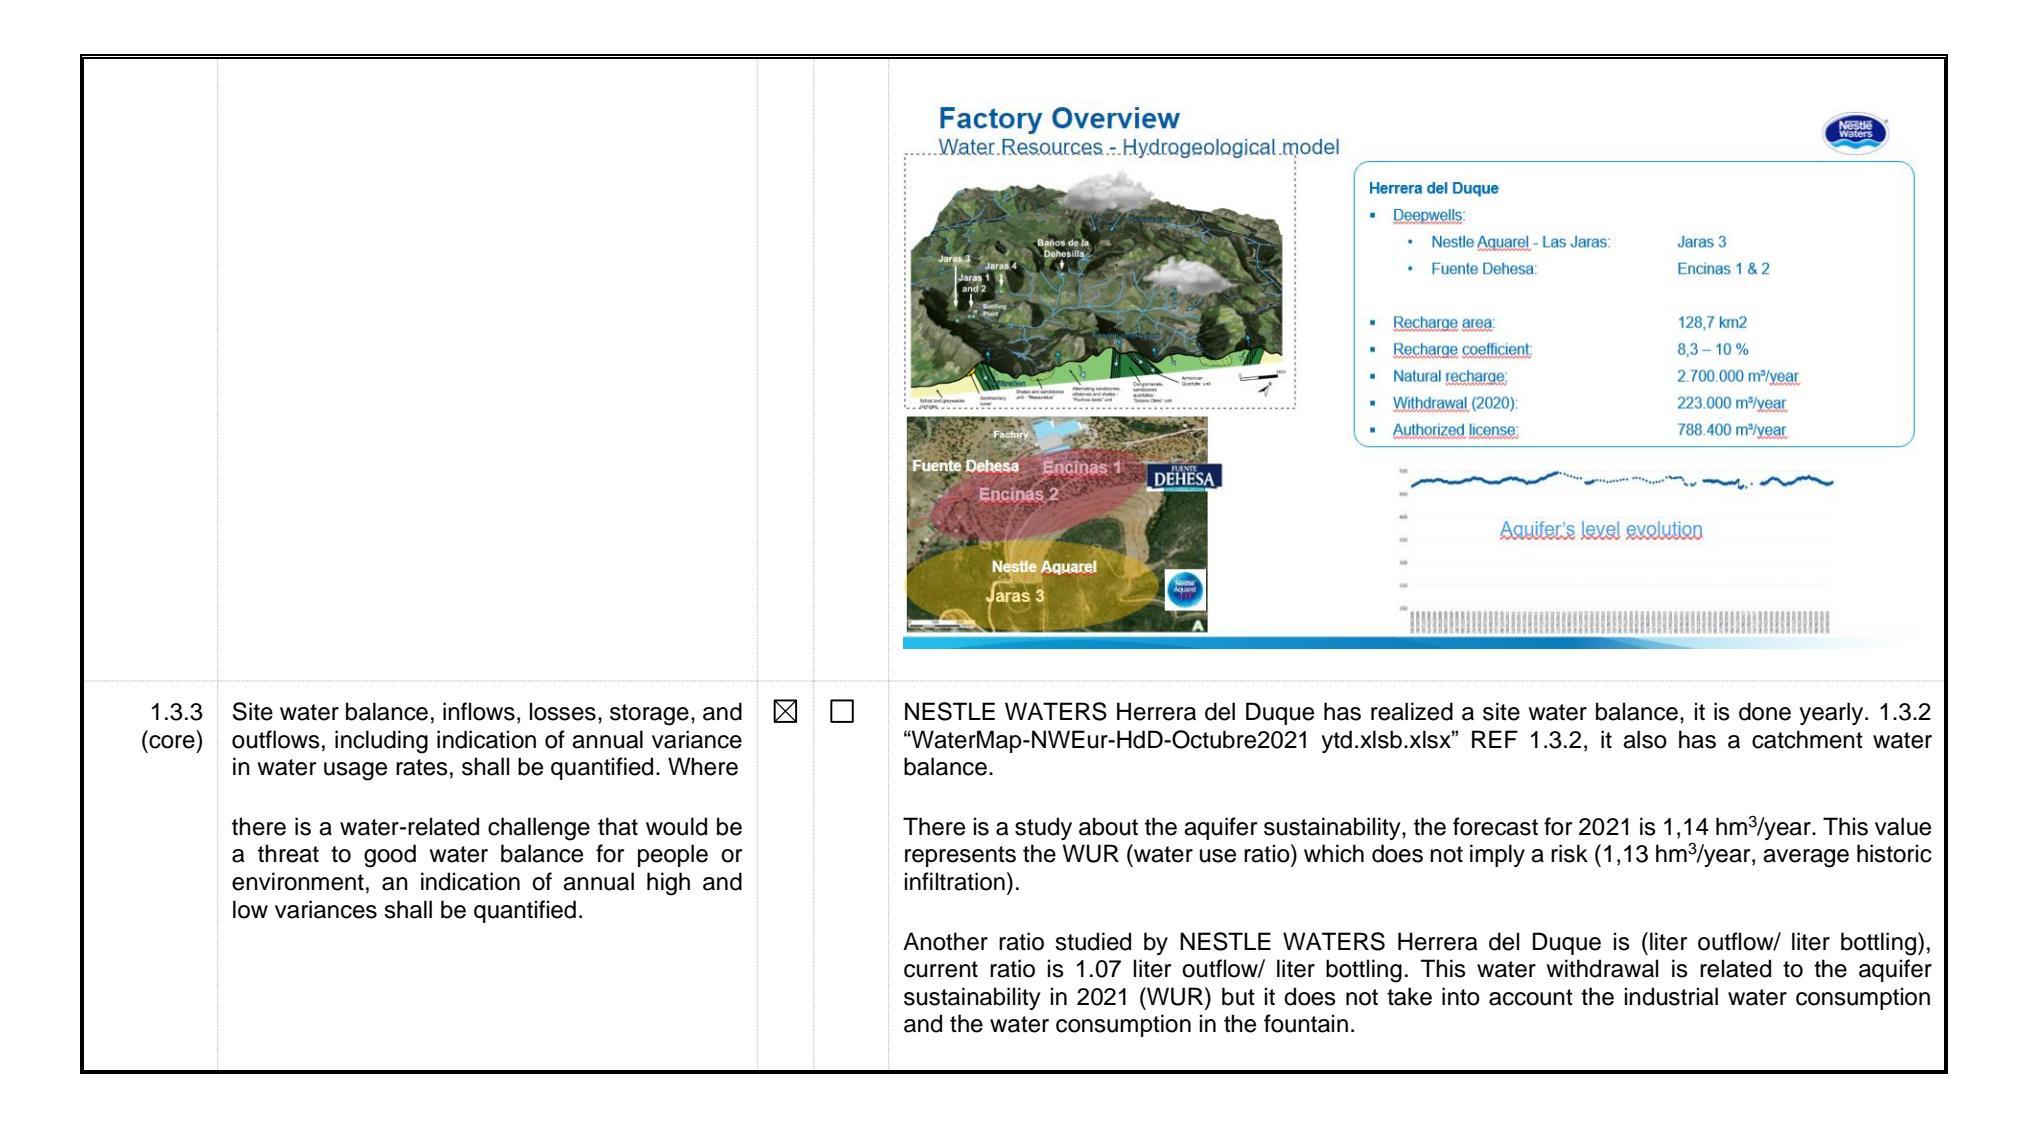
1.3.2 (core)	Site water balance, including inflows, losses, storage, and outflows shall be identified and mapped.			NESTLE WATERS Herrera del Duque has realized a site water balance, the losses, storage, and outflows has been mapped in "Balance Hidrico.pptx". REF1.3.4

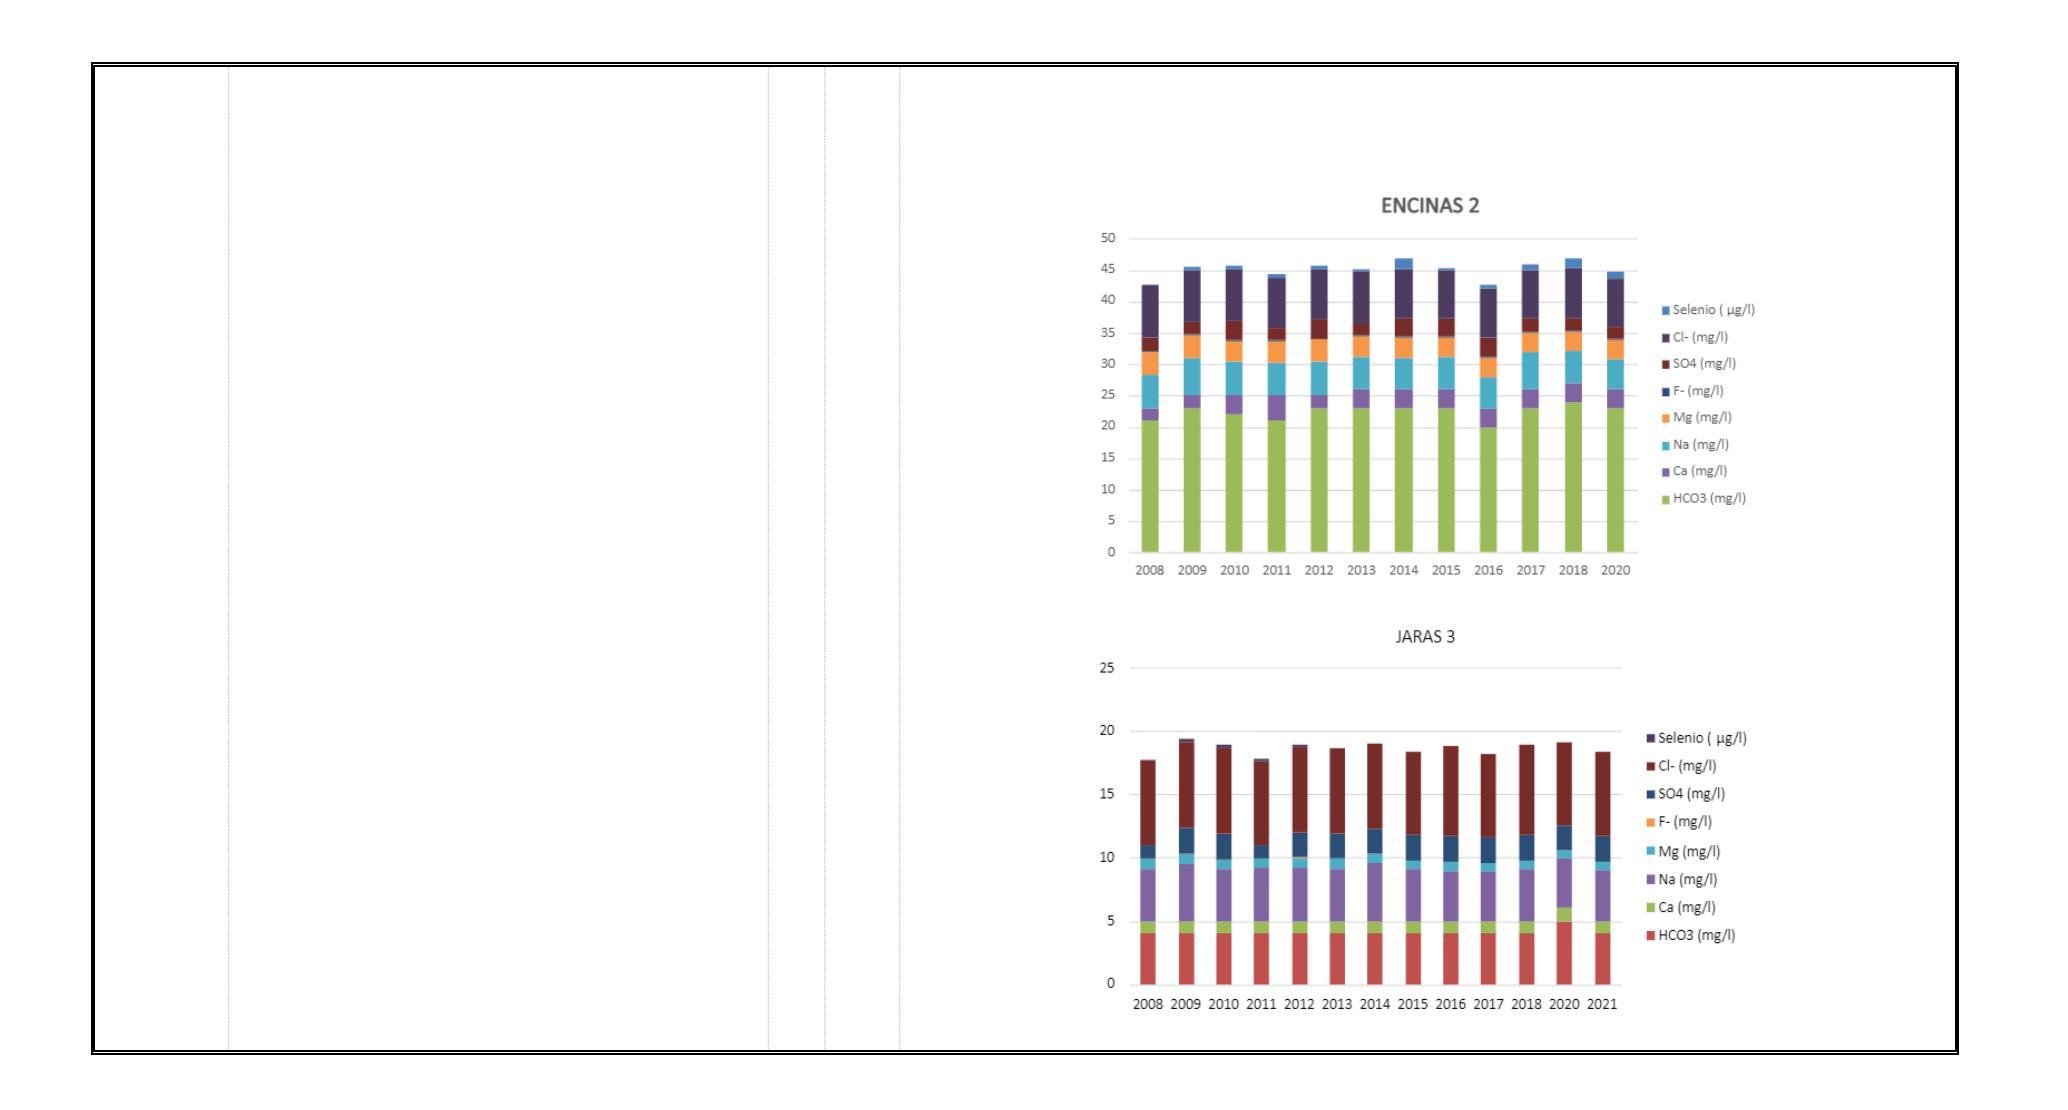
NESTLE WATERS Herrera del Duque checks ratio m <sup>3</sup> outflow / m <sup>3</sup> inflow in order to study the aquifer sustainability. This indicator of performance is checked each month and its evolution.
1.3.4 (core)	Water quality of the site's water source(s), provided waters, effluent and receiving water bodies shall be quantified. Where there is a water-related challenge that would be a threat to good water quality status for people or environment, an indication of annual, and where appropriate, seasonal, high and low variances shall be quantified.		NESTLE WATERS Herrera del Duque realize analysis periodically "1.3.4 Consolidation FQ- AMN.xlsx". REF 1.3.4 These analyses show the mineralization over the years is preserved and they have made yearly. as some examples the following graphics.

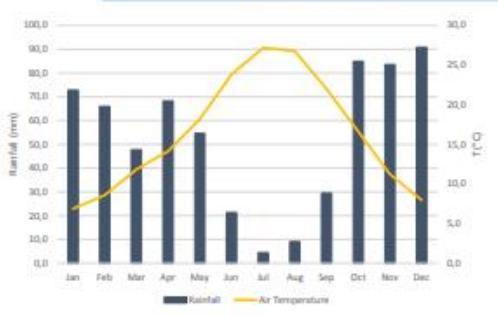
MONTHLY RAINFALL AND AIR TEMPERATURE

The recharge of the Armorican Quartzite aquifer occurs through precipitation. Any precipitation changes could directly impact recharge and the aquifer. In the last decade it seems evident increasing average values of temperature and a decrease in precipitation associated with weather variability and possible climatic changes. In long term, the aquifer's conditions could be positively or negatively impacted, depending on the evolution of the precipitation. In the context of climate change, severe climate variability and population growth, increased water demand, depletion of available water resources is expected. Supply variability require the increase of water resources and consequently the introduction of new research strategy and policies into the present water management systems.
