WATER STEWARDSHIP ASSURANCE SERVICES

Alliance for Water Stewardship (AWS)

Audit Number: AO-000239

Site: **Dynamic Electronics (Kunshan) Co., Ltd.** Address: 1688 Jinshajiang North Road, 215335, Kunshan City, Jiangsu, CHINA Contact Person: Joe Wang AWS Reference Number: AWS-000228 Site Structure: Single Site

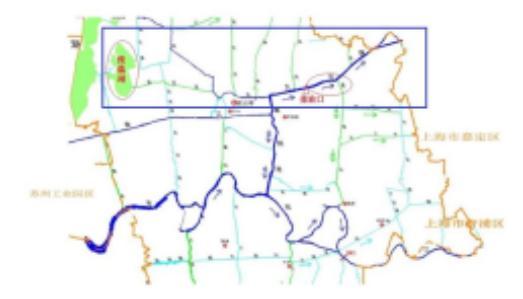
catchment map.jpg

The Wusong river is an important river in the Jiangsu Province, which originates from the Lake Taihu and flows to the Shanghai then into the sea.

It is 125 kilometre long, with 54km in the Shanghai region, and about 40 to 50 metre width. The occupied area of the catchment is about 855 km2, covers several regions including Wujiang, Suzhou, Kunshan, Jiading, Qingpu and Shanghai. Wusong river is a sub-catchment of Taihu Lake Catchment.

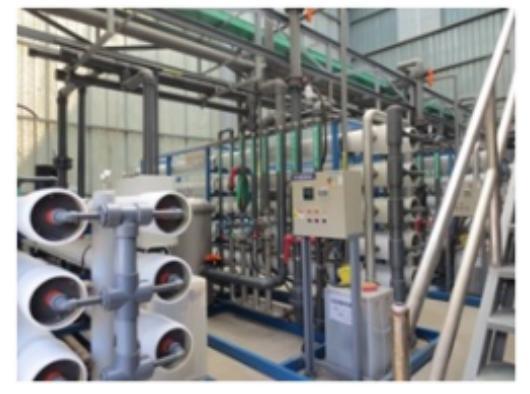
Pure water station.jpg

1.3.8	Levels of access and adequacy of WASH at the site shall be identified.	Vec
Comment	DE installed water purification facilities in workshops, office areas and dormitories, providing direct drinking water to employees. All the outlets of drinking water were tested by third party laboratory every month. The water purification facilities were regularly maintained by both DE and the supplier. DE provided sufficient toilets to workers, and regulary cleaning was conducted. Necessary equipment like handwash and tissue were also provided.

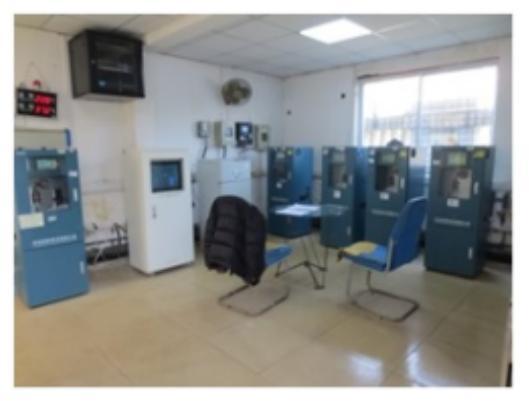
Online wastewater monitoring system.jpg

Comment	DE developed a reclaimed water system to treat and reuse wastewater. DE also installed an online monitoring system to monitor the industrial wastewater, including the parameters of COD and ammonia-Nitrogen, and conduct routine internal and external test of the rest parameters to control the industrial wastewater quality. The quality of rainwater and domestic wastewater was also monitored.

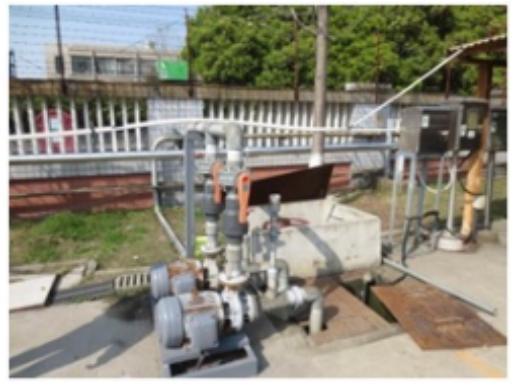
Rainwater Drainage.jpg

different discharged water flows into different pipeline. The rainwater is discharged into the municipal rainwater pipeline and then finally flows to Tongxin River. The industrial wastewater is treated by onsite wastewater treatment plant, the then emitted into the Lou River, flows to Taicangtang River, and finally flows into Yangzte river. The domestic wastewater is discharged into municipal sewage pipeline and then finally flows to Wusong River.
