WATER STEWARDSHIP ASSURANCE SERVICES

Audit Number: AO-000435

Site: **BAT Uzbekistan - Samarkand Cigarette Factory** Address: 140100, Samarkand region, Farkhad settlement, 140100, Samarkand, UZBEKISTAN Contact Person: Ravshan Khasanboev AWS Reference Number: AWS-000482 Site Structure: Single Site

Audited Service(s): AWS Standard v2.0 (2019) Audit Type(s): Initial Audit Audit Start Date: 2022-Nov-20 Lead Auditor: Tanya Christensen

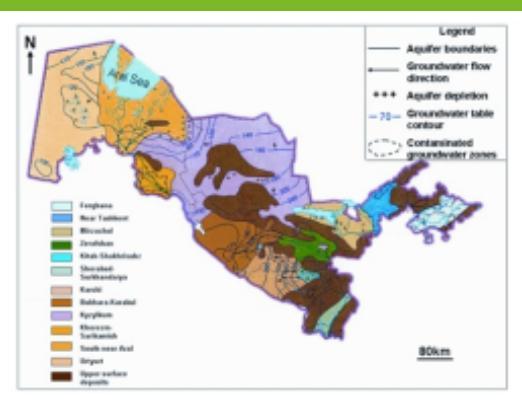
Hydrogeology map of Uzbekistan.jpg

The site has prepared a 'catchment description' document, which is attached for reference, that goes into detail explaining the surface and groundwater resources in Uzbekistan and their current status. The main rivers of the Republic of Uzbekistan are: The Amu Darya, formed at the confluence of the Vakhsh and Pyandj Rivers; the Syr Darya, formed at the confluence of the Naryn and Karadarya Rivers; and the Chirchik near Tashkent. The Amu Darya basin includes the Surkhandarya, Sherabad, Kashkadarya, and Zarafshan rivers, but only the Kashkadarya and Sherabad are located entirely within Uzbekistan. In addition to the main rivers, there are more than 17.7 thousand natural watercourses in Uzbekistan.

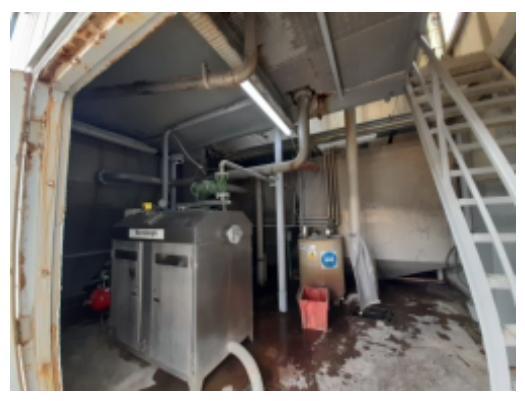
SCF inside WWTP.jpg

The site operates a closed-loop water management system, with no municipal supply or municipal wastewater treatment. There are 4 boreholes onsite: BH1 & 2 are used for all site and production demands. BH3 & 4 are not used for production, one is not operational, but available for backup and one is used for irrigation. The site operates a WWTP which is starting to age out (20 years) and it can process 100m3 a day, any discharged water is sent via a canal to an onsite lined evaporation pond. During a heavy rainfall, there is an overflow from the pond to the canal. CAPEX has been signed off to design and develop a new WWTP that can process 150m3 a day and will make the receiving pond redundant.

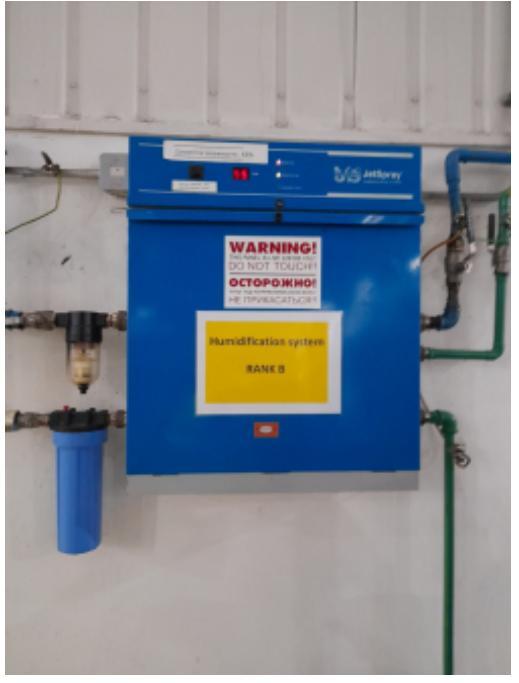
SCF Humidification System.jpg

The SCF operates two shifts and is closed at the weekend. Humidification is kept at 63% in the cigarette rolling area, if the cigarette paper is too dry, then it will break during rolling process. Compressed air and vacuums are used for cleaning machinery, not water. In terms of cleaning, water is only used for cleaning the floors. The factory has one machine that uses steam, which is used to compress the filter rods. A humidification system is also used in the packing area, using mist to remove any dust. Some stem is used for heating, but cooling is not required as the roofs are insulated for the Uzbekistan summers.
