WATER STEWARDSHIP ASSURANCE SERVICES

Alliance for Water Stewardship (AWS)

Audit Number: AO-001410

Site: **Mengniu Dairy (Qujing) Co., LTD** Address: Qingshan Industrial Park, Luliang County, Qujing City, Yunnan Province, 655600, Qujing, Yunnan, P.R. CHINA Contact Person: yansheng wang AWS Reference Number: AWS-000771 Site Structure: Single Site

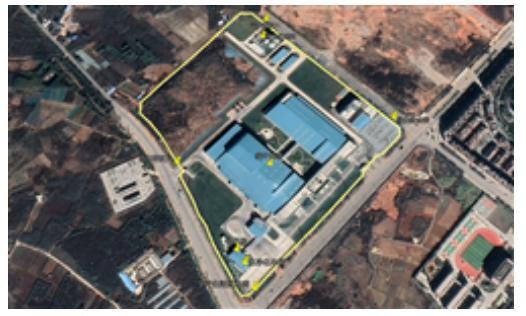
Site boundary.png

Comment	 The site draws a site boundary map, which identifies the site boundary information and the layout within the site. The site also collects information on the destination of its wastewater discharge, the location of the final receiving water body, the location of water service providers, and their water sources. The site has developed the following maps: Map of site boundaries with the source of water supply and discharge points of wastewater. Map of water-related infrastructures at the site such as pipeline, and wastewater treatment plant. Map of the water plant including Da Ba Chong Water Plant, Bei Shan Water Plant, Song Shan Water Plant, and Lian Hua Tian Water Plant, along with their ultimate water sources (Da Ba Chong Reservoir, Lian Hua Tian Reservoir, Bei Shan Reservoir, and Pu Shan Reservoir), municipal wastewater treatment plant (Guozhen Environmental Technology Co., Ltd.), and its ultimate receiving water body (Nanpan River). Map of the catchment that the site affects and is reliant upon for water.

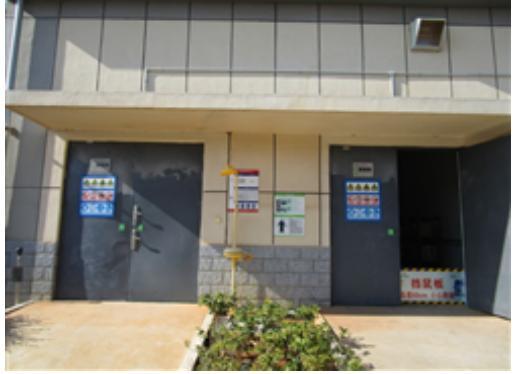
Chemical storage area-2.JPG

1.3.5	Potential sources of pollution shall be identified and if applicable, mapped, including chemicals used or stored on site.	✓′es
Comment	The site has identified potential sources of pollution such as the Wastewater conveyance pipeline network, chemical storage and usage, wastewater tanks, and storage of hazardous waste, and relevant measures to prevent and control contamination have been taken including strengthening management, establishment of secondary containment, and emergency response. In addition, the site has mapped the identified potential sources of pollution.

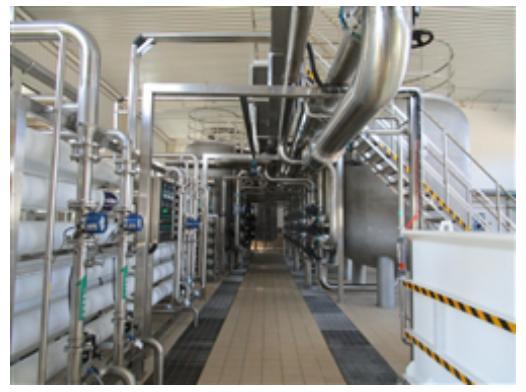
water treatment system.JPG

Comment	The site has developed a water quality monitoring inventory, which includes monitoring requirements for sewage, incoming water, drinking water, recycled water, and pure water for production, including monitoring points, monitoring methods, pollutant names, monitoring frequency, and control standards. For example: - Industrial and domestic wastewater: Both industrial and domestic wastewater are treated by the on-site wastewater treatment system and then combined wastewater will be discharged to the off-site wastewater treatment station for further treatment. According to the requirements of the wastewater discharge permit, the site regularly entrusts a third-party laboratory to test the discharge outlet to monitor pH, COD, ammonia nitrogen, TN, and TP in real time; - Internal laboratory conducts daily testing of industrial wastewater discharge outlet and wastewater treatment processes. - Drinking water - The site annually commissions a third-party laboratory to test the quality of incoming water, in accordance with its internal standard: T/CS-2.3.6-4-2023-4, which is stricter than the national standard GB 5749-2022, Health Standards for Drinking Water. - The internal laboratory conducts daily tests on pure water and softened water prepared by the water treatment system. - The internal laboratory conducts daily tests on pure water and softened water prepared by the water treatment system.	t

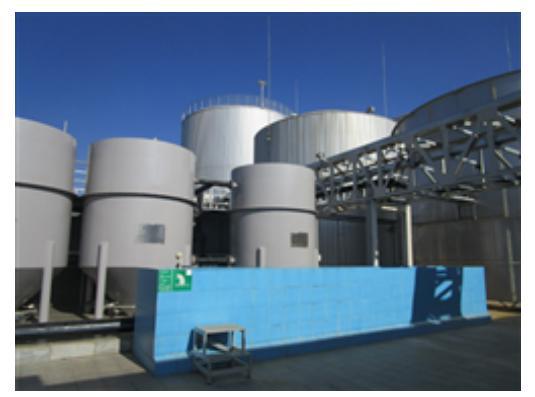
waste water treatment station.JPG

The site has one wastewater discharge outlet. Both production and domestic wastewater are channeled into the site's internal wastewater treatment station. After being treated to meet the discharge permit limits, the wastewater is discharged into the municipal wastewater network and further treated by external wastewater treatment infrastructure before being released into the Nanpan River.

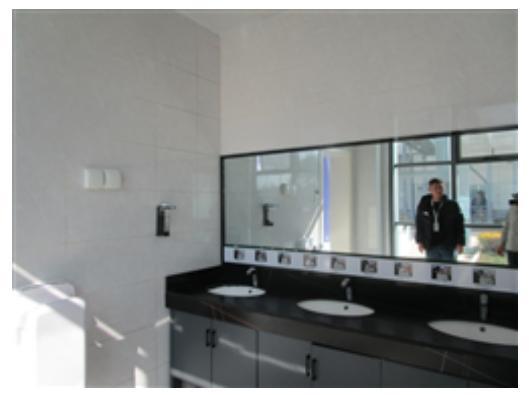
Toilet-3.JPG

Comment	The site has a complete toilet plot process and detailed record of the table, and there is a clear standard labeling and water conservation identification on the scene. The site is satisfied and meets the relevant requirements of gbz1-2010, and the relevant requirements of gbz1-2010 sanitary design standard for industrial enterprises and site also set up enough water dispensers to provide water for employees, and the water dispenser has a regular maintenance and replacement of the filter core, and the water dispenser is regularly maintained and replaced, and the water water is tested regularly, and the test report results are consistent with the standard.
