WATER STEWARDSHIP ASSURANCE SERVICES

### Alliance for Water Stewardship (AWS)

Audit Number: AO-001444

Site: Haleon - Jacarepaguá, Rio de Janiero Address: Godofredo Marques, 274, 22783130, Rio de Janeiro, BRAZIL Contact Person: Graziela Soares AWS Reference Number: AWS-000711 Site Structure: Single Site

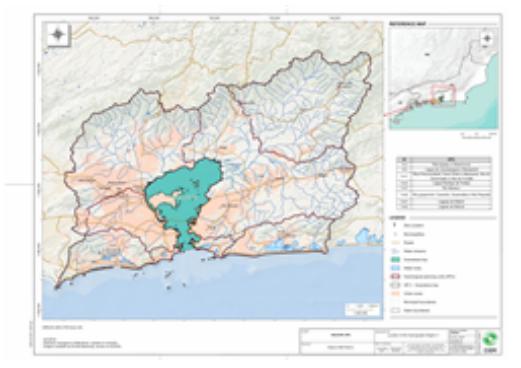
1.1.1\_Hydrographic\_Region\_Guanabara\_Bay.jpg

The Site itself, and its wastewater point of discharge (Caçambé River), are located in the Baía de Guanabara watershed, which comprises an area of approximately 4,820 km<sup>2</sup>. Additionally, this basin drains the area of 17 municipalities of the Rio de Janeiro State.

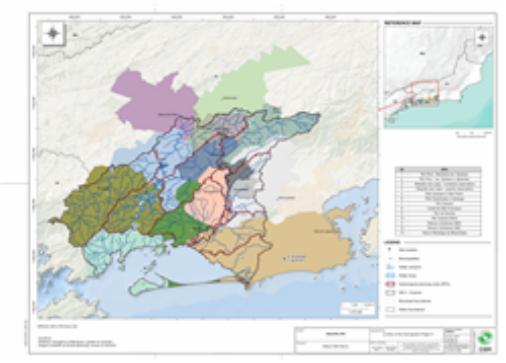
1.1.1\_Hydrographic\_Region\_Guandu.jpg

The watershed of Guandu, which comprises Guandu River, is the ultimate water source for the Site and spreads across an area of 1,385 square kilometers (km<sup>2</sup>). The Guandu River basin drains the area of 15 municipalities of the Rio de Janeiro State. According to the Executive Report of the Strategic Plan for Water Resources of the Guandu River Basin, issued in 2018 by Guandu Basin's Committee, there are around 1.94 MM habitants living in this area. The volume of the Guandu River is also the result of the transposition of the mighty Paraíba do Sul River – which passes through the states of São Paulo, Minas Gerais and Rio de Janeiro –, a reality that had the purpose of generating energy and supplying the population of the Metropolitan Region of Rio de Janeiro.

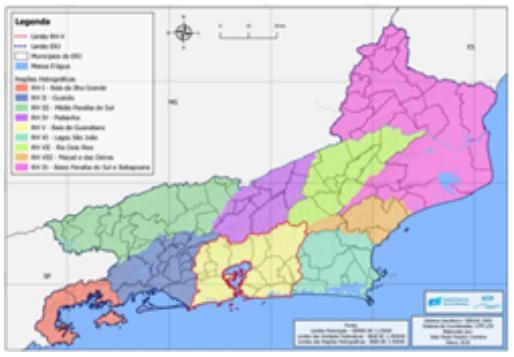
1.1.1\_Regiões\_Hidrográficas\_do\_Rio\_de\_Janeiro.jpg

Rio de Janeiro State is divided into nine (09) hydrographic regions. The Site itself and the Site's wastewater point of discharge is located in Hydrographic Region V (shown in orange in Map 5), which is called Baía de Guanabara Hydrographic Region (RH V). However, treated water from the Guandu River, responsible for Site's water supply, is located in Hydrographic Region II (shown in purple in Map 5), named Guandu Hydrographic Region (RH II).

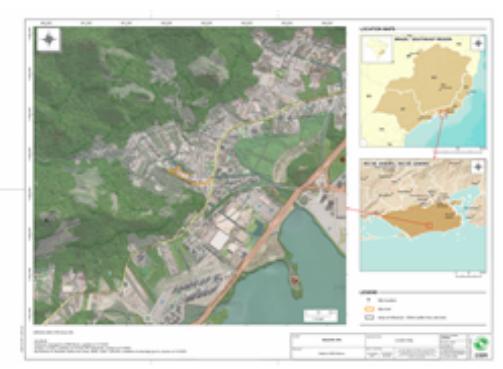
1.1.1\_Site's\_Location\_Satellite\_Image.jpg

The Site is located in Estrada dos Bandeirantes (road), number 8464, Jacarepaguá District, Rio de Janeiro - RJ, Brazil.

The Site is surrounded by a residential area to its north and northeast, a dense vegetation area to its southwest and a Convention Center - Rio Centro – to its southeast. Additionally, there is the Caçambé River located approximately 20 meters (m) north of the Site and the Camorim River approximately 110 m south of the Site. The Site is involved in manufacturing of consumer healthcare products such as pain relief, vitamins, oral health products and nutrition/gastrointestinal ones.

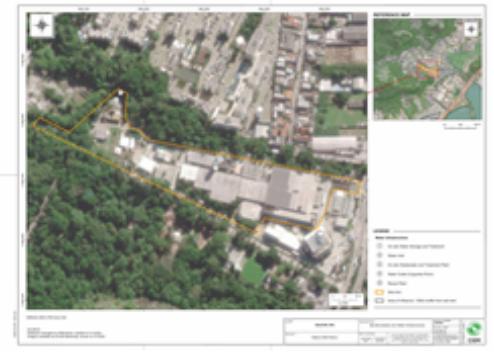
1.1.1\_Site's\_Boundaries\_Satellite\_Image.jpg

The overall area of the Site is around 4.10 hectares and it consists of various utilities such as administrative buildings, maintenance buildings, production areas, wastewater infrastructures, among others.

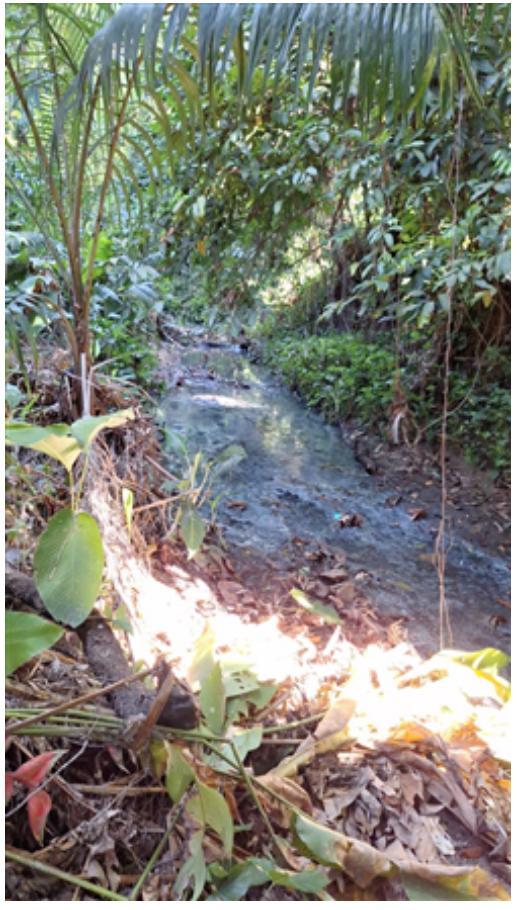
upsteam.jpeg

Comment	The treated effluent disposal point was visited. The water source location was not visit because it is far from the site and it would be necessary 5 hours to visit the place. The treated effluent disposal point is at Caçambé creek. The river banks and its vegetation appear to be in good condition of conservation, but it is clear that the quality of the river wat is already compromised due to pollution from upstream.	er

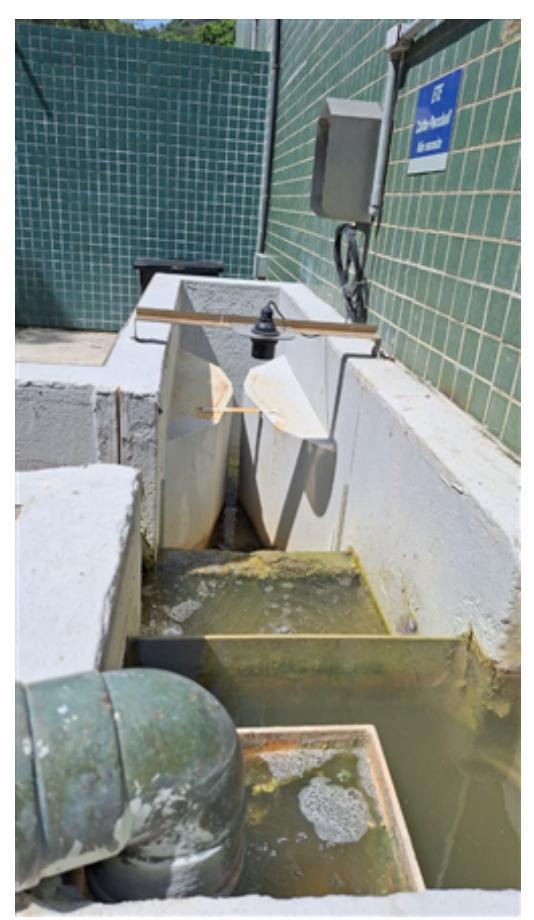
Treated effluent.jpeg

Comment	It was identified that the release of effluent with a higher quality than the Caçambe River's own water is a good practice to be applied by the site, since the resulting dilution will result in a water condition superior to that of the river itself. It was also identified that having a water efficiency management program, which requires more production, but with less water consumption, will contribute to both basins, since we will require less water in the collection and less effluent in the discharge.
	Haleon has its PiE (Pharmaceuticals in the Environment) Improvement Program, which is governed by the Global Corporate Standard (applicable to all sites), D1- Environmental Compliance Standard - QD-STD-003648, and by the Technical Support Document D1.4-Pharmaceuticals in the Environment - QD-SOP-039086. These standards establish the requirements for the management of pharmaceutical products in the environment (PiE) associated with Haleon's operations, ensuring that its production activities minimize/eliminate the risk that effluent discharge may cause adverse environmental impacts. The PiE Improvement Program review process is carried out on a recurring basis, in which a Gap Analysis is performed on the site's situation in relation to the APIs handled and the control processes that mitigate/eliminate a potential discharge of active pharmaceutical ingredients and environmentally hazardous materials into wastewater and, in turn, into surface water

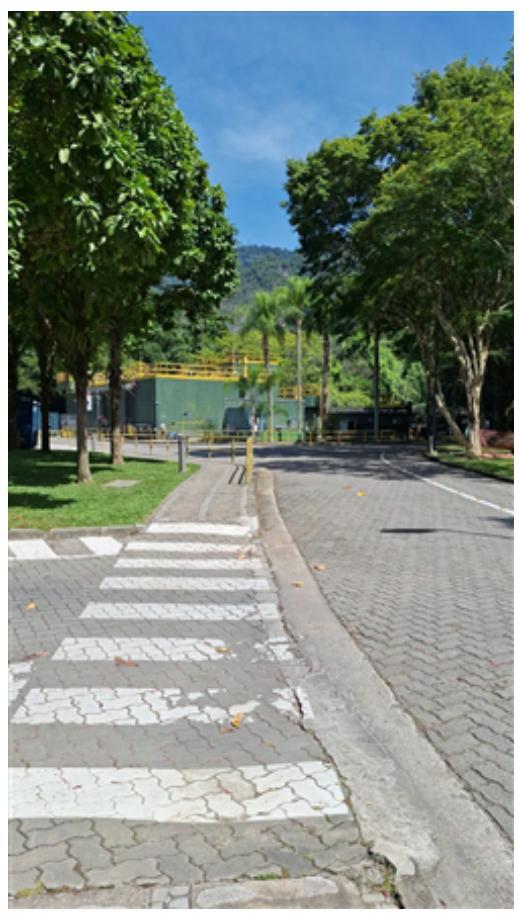
effluent treatment plant.jpeg

The various treatment stages of the Site's WWTP include flocculation, equalization, deoxygenation, surface aeration and decantation.

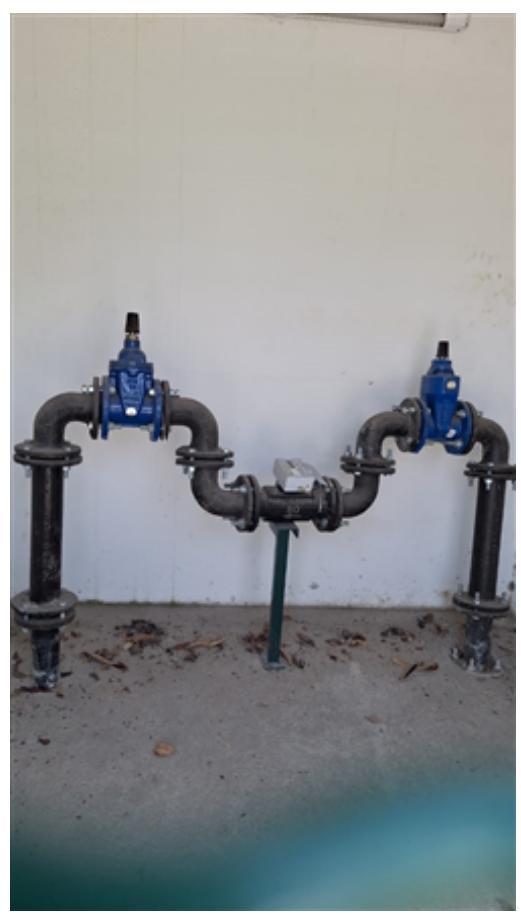
IGUÁ water inlet hydrometer.jpeg

The Site's water is supplied by Iguá Saneamento, a private sanitary agency responsible for the water distribution within the Site's region. Water gallons are bought from Acqua Futura to supply Site's water for drinking purposes (water source is from weell located between south-central fractured aquifer and northeast-southeast coastal aquifer). Treated water supplied by Iguá Sanemanto is used in the Site for three different purposes: utility supply, general consumption and the production process.

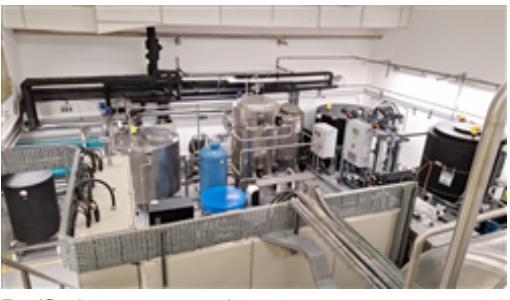
Purified water sector.jpeg

Production Process: Purified water - Cleaning In Place processes and incorporated into the product

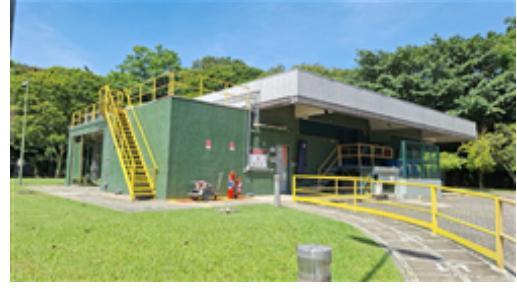
Flammable and solvent storage.jpeg

Comment The Emergency Response Plan identifies potential sources of pollution within the plant (diesel tanks, raw material tanks, flammable liquids, flammable gases, substation, generators, storage of hazardous waste and used chemicals). The Site provided an inventory of chemicals. At IT-EHS-OPERAÇÃO DIQUE DE CONTENÇÃO there is the "Figura 2- Layout planta de Jacarepaguá" with the location of points where there are chemicals/potential contaminants in the unit.
