AWS Conformity Assessment

Coca-Cola HBC Lietuva, UAB

AWS reference AWS-000267

10-11/08/2020 **Assessment dates:**

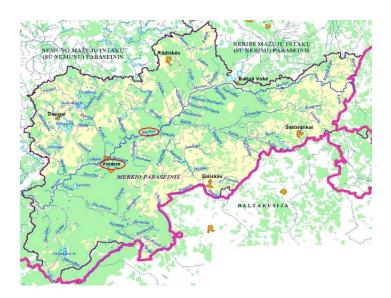
Description of the catchment:

The site is dependent on the Nemunas Basin Region and sits on top of the Lower Chalk Aquifer system. The groundwater flow from south to north across the UAb " Neptūno Vandenys " site. The approximate depth to water is 12.5 m below ground level.

The site is located approximately 4 km to the south east of the river Merkys. The river Merkys flows for 13 km through Belarus and is a significant river in the region. 5 km along the Belarus and Lithuanian border. All length of the river is 203 km, in Lithuania territory is 185.2 km before joining river Nemunas near small village Merkinė. A series of interconnecting lakes and streams are located approximately 1.2 km to the north of the site, which feed into river Merkys to the northwest. Merkys is mostly fed by underground streams.
