# CERTIFICATION REPORT

## Alliance for Water Stewardship (AWS)

Audit Number: AO-000285

Site: **Johnson & Johnson - Bangkok**

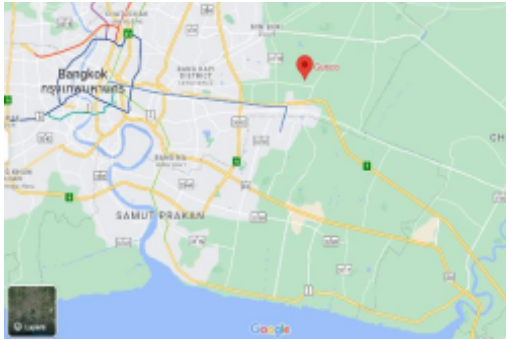
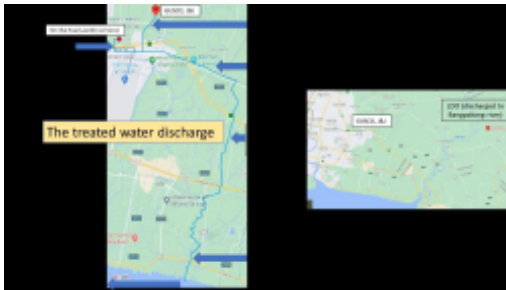
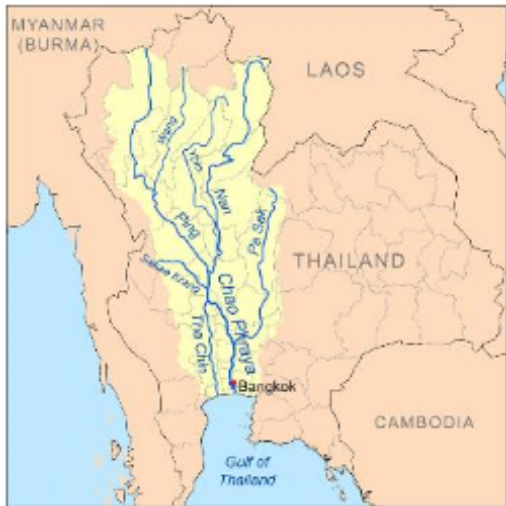
### Catchment Information

The J&J Thailand site is located in the LKB Industrial Estate, which is on the Eastern outskirts of Bangkok. The site is owned by the Industrial Estate Authority of Thailand (IEAT) and all water and waste water is managed by the onsite water supply company GUSCO, who receive all the water for the Estate from the Municipal Water Authority. The Metropolitan Water Authority (MWA) extracts all its water from the Chao Phraya river, which is the major river in Thailand. The river supplies water to about 20-25% of Thailand and is considered a major water highway. The low alluvial plain of the Chao Phraya forms the centre of the country, flowing through Bangkok and into the Gulf of Thailand. The MWA can also extract water from the neighbouring Tha Chin river. WSAS notes that the site still needs to undertake some work to understand its water catchment better.
