CERTIFICATION REPORT

Alliance for Water Stewardship (AWS)

Audit Number: AO-000390

Site: **ITC Kovai Plant**

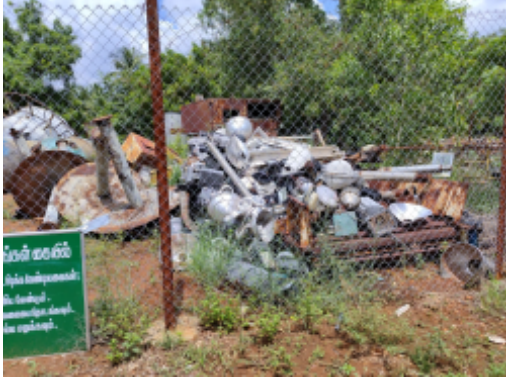
E-hazardous waste stored in open.jpg

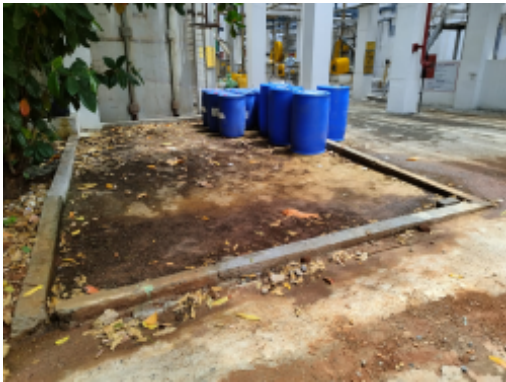
Finding No: TNR-001879
Checklist Item No: 1.3.5
Status: Open
Finding level: Observation
Checklist item: Potential sources of pollution shall be identified and if applicable, mapped, including chemicals used or stored on site.
Findings: During the audit trail of the plant site area, lubricant drums were found stored in the scrap material area, which could act as a potential source of oil spillage causing surface water runoff pollution. Similarly, no pallets were observed beneath the stored oil drums to arrest any anticipated oil spillage.

Oil drums without pallet stored in open.jpg

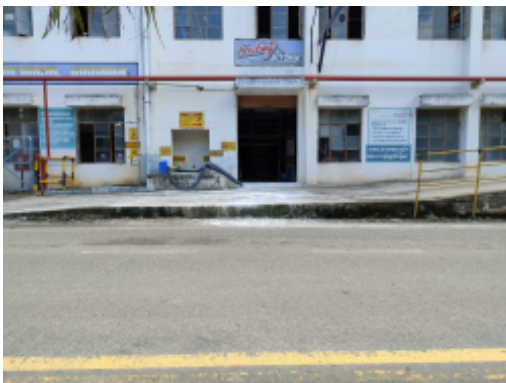
Finding No: TNR-001880
Checklist Item No: 1.3.5
Status: Open
Finding level: Observation
Checklist item: Potential sources of pollution shall be identified and if applicable, mapped, including chemicals used or stored on site.
Findings: During the audit trail of the plant site area, Chemical spillage near the vacuum pump area was observed.

chemical spillage near vaccum pump station.jpg

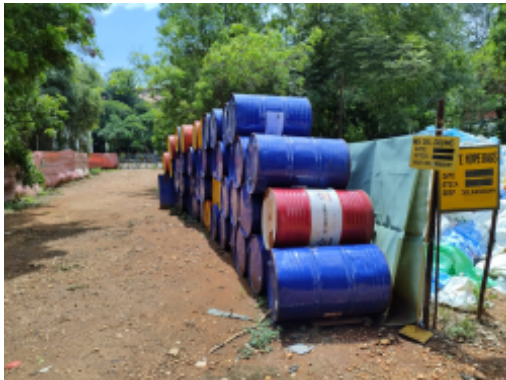
Lubricant drums without pallet stored in open.jpg
