CERTIFICATION REPORT

Alliance for Water Stewardship (AWS)

Audit Number: AO-000516

Site: **Luxshare - (158) Kunshan, China**

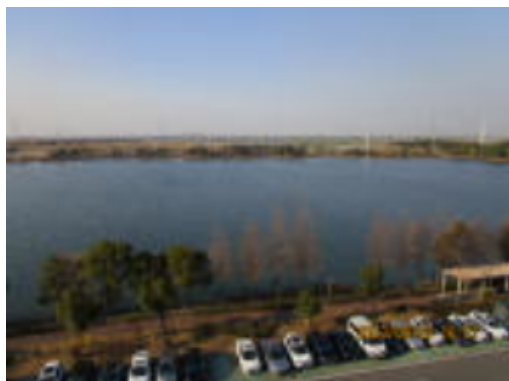
Baijiadang Lake.JPG

Comment Luxshare identified Baijiadang Lake as its on-site IWRA. Baijiadang is a small lake with a total circumference of 2.24 kilometers and a water area of about 140674 m3. Area D of the site is adjacent to Baijiadang, and area E of the site is surrounded by Baijiadang and its tributaries. The site irregularly maintains the water surface sanitation and salvages the floating objects on the water surface.

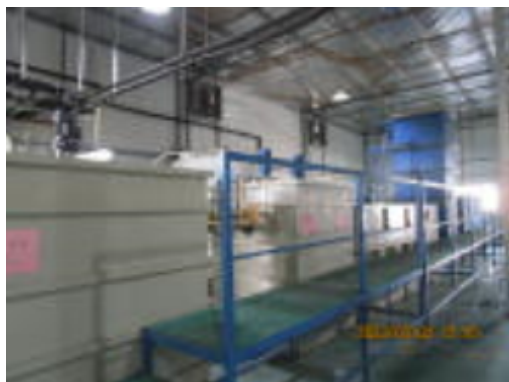
Wastewater treatment plant (2).JPG

Comment	<p>After being treated by the internal wastewater treatment facilities, the industrial wastewater of the site is all reused in the production process, and no industrial wastewater is discharged. The site's industrial wastewater is recycled as much as possible after being treated by its internal wastewater treatment facilities. A small amount of concentrated wastewater generated after being concentrated by the second-effect evaporation system is finally treated as hazardous waste.</p> <p>The site has developed a Water Stewardship Plan (Year 2022) improvement action list, which specifies targets, required actions, measurement, status, effectiveness evaluation, accountable and deadline, etc.</p> <p>According to the 2021 water balance test report of the site, its water resource reuse rate is 99.13%. The site also monitors its wastewater reuse rate by itself according to the water balance test specification. According to the statistical analysis records provided by the site, the industrial wastewater reuse rate was 92.7% in 2021 and 93.3% in 2022.</p> <p>A series of project plans are implemented and continuously tracked, such as:</p> <ul style="list-style-type: none"> Industrial water recovery technical transformation project to increase the water production capacity of the pure water system; Gradually replace with water-saving faucet; Reduce single water consumption of toilet water tank in staff dormitory. <p>The site tracks the progress of its Water Stewardship plan regularly.</p>

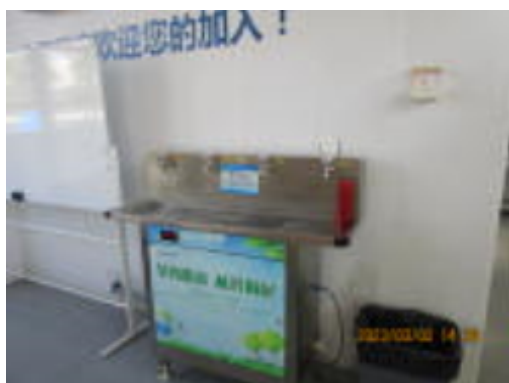
Drinking water.JPG

Comment Luxshare provides dormitories and canteen for employees. Sanitation and hygiene installations and water purifiers are also installed at office buildings, dormitory areas and all workshops. The WASH installations fully comply with the national "Hygienic Standards for the Design of Industrial Enterprises" (GBZ 1-2010).
The site also conducts WBCSD self-assessment to evaluate the level of onsite WASH. The result is satisfied.

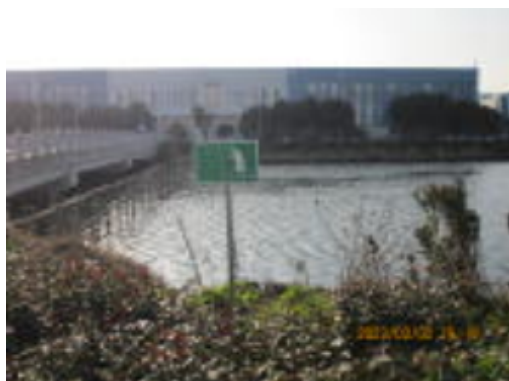
Rain water discharge point.JPG

Comment Rainwater and domestic wastewater are discharged separately through different pipe networks. Luxshare drew a rainwater and sewage pipe network diagram, and the rainwater and wastewater transmission pipelines were mapped.
Luxshare also drew a map of potential pollution sources, wastewater treatment facility, waste storage areas and chemical storage areas were identified. The site also identifies the pollution factors of each potential pollution source.

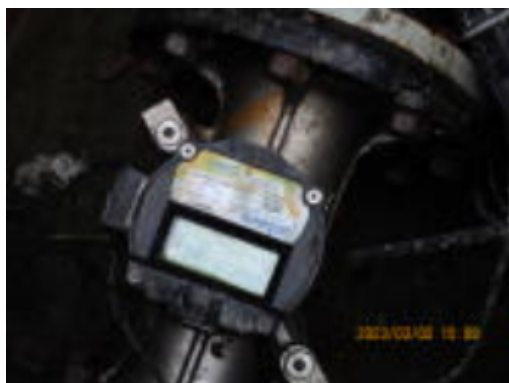
Water meter.JPG

Yes
Comment	<p>Luxshare tracks the readings of each water meter every month and carries out water balance analysis every year.</p> <p>The site has recorded the income and input and output data via meter or estimation, and developed a water balance map based on the data. The water balance map reflected the water inflows, losses, reuses and outflows.</p>
