CERTIFICATION REPORT

Alliance for Water Stewardship (AWS)

Audit Number: AO-000517

Site: **Luxshare - Lanto (399) Kunshan, China**

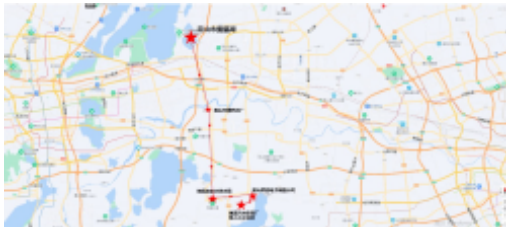
site catchment map.jpg

Based on the location of water source, final discharge receiving body and the boundary of the factory, all of them located in the Kunshan Section of Wusong River Basin. The length from west to east of the Wusong River in Kunshan City is about 40 kilometers, entering Kunshan from Suzhou Industrial Park (Jianglizhuang Section under provincial control), and passing through Kunshan and then enters Shanghai (Shipu section under state control). The Wusong River is an important river in the Jiangsu Province, which origins from the Lake Taihu and flows to the Shanghai then into the sea. Wusong River is a sub-catchment of Taihu Lake Catchment.

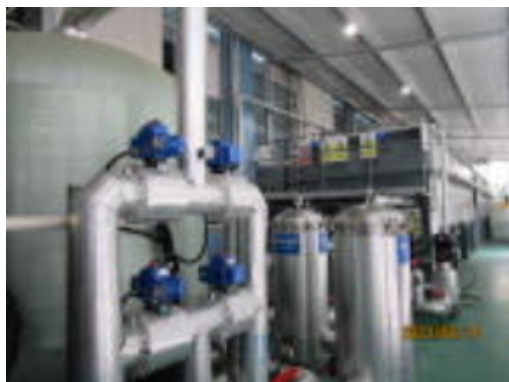
Wastewater treatment plant.JPG

Comment After being treated by the internal wastewater treatment facilities, the industrial wastewater of the site is all reused in the production process, and no industrial wastewater is discharged. The high concentration tin mesh cleaning waste liquid in Lanto's workshop is directly treated as hazardous waste. The site has developed a Water Stewardship Plan (Year 2022) improvement action list, which specifies targets, required actions, measurement, status, effectiveness evaluation, accountable and deadline, etc. According to the 2019 water balance test report of the site, its water resource reuse rate is 89.8%. After that, the site monitors its wastewater reuse rate by itself according to the water balance test specification. Up to now, the data is about 92%. A series of project plans are implemented and continuously tracked, such as: Industrial water recovery technical transformation project to increase the water production capacity of the pure water system; Gradually replace with water-saving faucet; Reduce single water consumption of toilet water tank in staff dormitory.

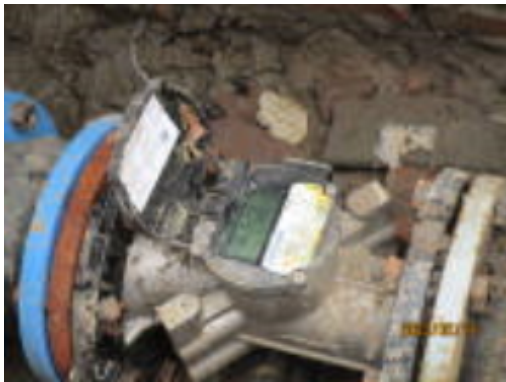
Water meter.JPG

Yes
Comment	<p>Lanto tracks the readings of each water meter every month and carries out water balance analysis every year.</p> <p>The site has recorded the income and input and output data via meter or estimation, and developed a water balance map based on the data. The water balance map reflected the water inflows, losses, reuses and outflows.</p>

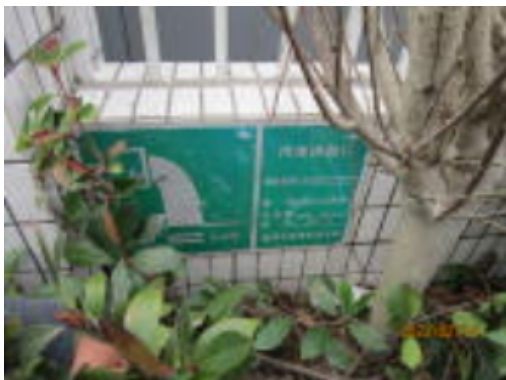
Domestic wastewater discharge point.JPG

The wastewater is discharged into Kunshan Jinxi Sewage Treatment Plant (the municipal WWTP) and finally discharged into the Xiaojieing River. The rainwater is discharged into the municipal rainwater pipeline and then finally flows to Baijiadang Lake and its tributaries. The water source, discharged water receiving body and the site, are located in Wusong River Basin. The length from west to east of the Wusong River in Kunshan City is about 40 kilometers, entering Kunshan from Suzhou Industrial Park (Jianglizhuang Section under provincial control), and passing through Kunshan and then enters Shanghai (Shipu section under state control). The Wusong River is an important river in the Jiangsu Province, which origins from the Lake Taihu and flows to the Shanghai then into the sea. Wusong River is a sub-catchment of Taihu Lake Catchment.

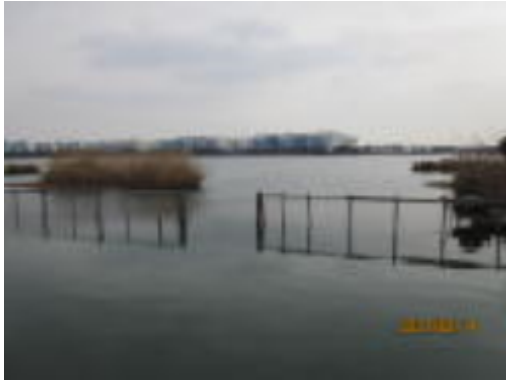
Baijiadang Lake.JPG

Comment	Lanto identified Baijiadang Lake as its on-site IWRA. Baijiadang is a small lake with a total circumference of 2.24 kilometers and a water area of about 140674 m3. Area D of the site is adjacent to Baijiadang, and area E of the site is surrounded by Baijiadang and its tributaries. The site irregularly maintains the water surface sanitation and salvages the floating objects on the water surface.

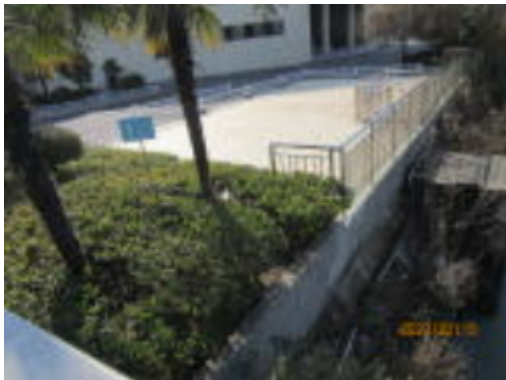
Rain water discharge point.JPG

Yes
Comment	<p>Rainwater and domestic wastewater are discharged separately through different pipe networks. Lanto drew a rainwater and sewage pipe network diagram, and the rainwater and wastewater transmission pipelines were mapped.</p> <p>Lanto also drew a map of potential pollution sources, wastewater treatment facility, waste storage areas and chemical storage areas were identified. The site also identifies the pollution factors of each potential pollution source.</p>

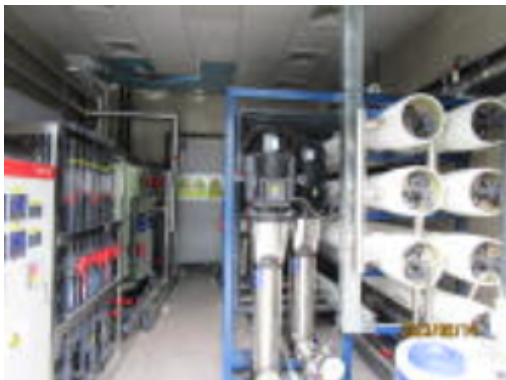
Purifera water system.JPG

Comment The site entrusts a third party laboratory to monitor the quality of its process ultra-pure water every year. The site controls the quality of its pure water according to the EW Class II standard of industrial ultra-pure water quality standard of the People's Republic of China GB/T 11446-1997(a recommended standard, not compulsory standard). At present, the pure water quality of the site has reached the EW Class I standard (more stringent than EW Class II)

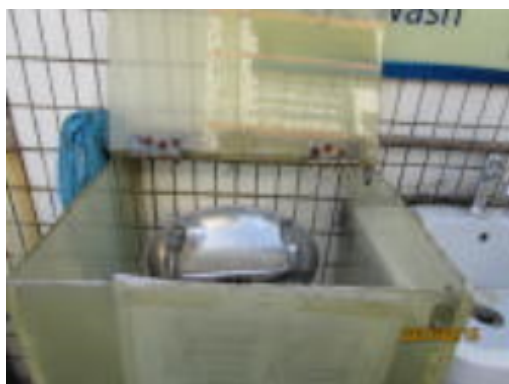
Eye washing facility.JPG

1.3.8	<i>Levels of access and adequacy of WASH at the site shall be identified.</i>	Yes
Comment	Lanto provides dormitories and canteen for employees. Sanitation and hygiene installations and water purifiers are also installed at office buildings, dormitory areas and all workshops. The WASH installations fully comply with the national "Hygienic Standards for the Design of Industrial Enterprises" (GBZ 1-2010). The standard included the requirement such as number of available toilets, separate toilets for Male and female, privacy and hygiene facility of toilets. The site also conducts WBCSD self-assessment to evaluate the level of onsite WASH. The result is satisfied.
