AUDIT REPORT

Alliance for Water Stewardship (AWS)

Audit Number: AO-001371

Site: **Nestlé Waters Thailand - Ayutthaya**

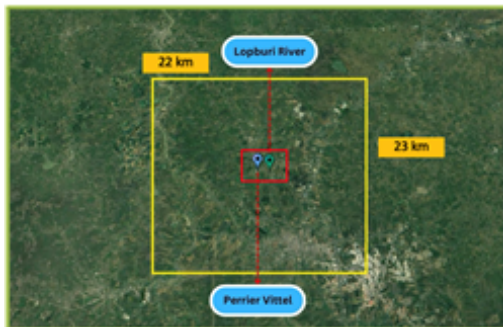
Catchment Map.png

The factory is situated in Pho Sam Ton Sub-district, Ayutthaya Province in the Central Plain of the Lower Chao Phraya Basin.

The catchment area was defined based on Hydrogeological Regime. The catchment is the most fertile plains for agriculture in the country. It is low plain with very few and very tiny natural forest patches. There are four main rivers: Chao Phraya, Pa Sak, Lop Buri and Noi Rivers.

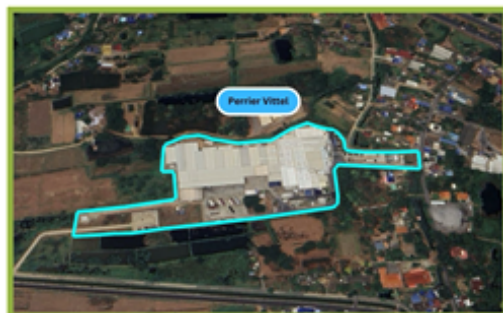
Site Map.png

The Site is located in Pho Sam Ton Sub-district, Bang Pa Han District, Ayutthaya which is within the lower Chao Praya River Basin. The Site is part of the Nestle Waters Group. It produces purified bottled water and natural mineral bottled water in 4 sized (330 ml., 600 ml, 1.5 liters and 6 liters). Raw waters are directly extracted from deep wells groundwater located within its boundary. These deep wells are legally licensed by Department of Ground Water via the Ayutthaya Provincial Office of Natural Resources and Environment.

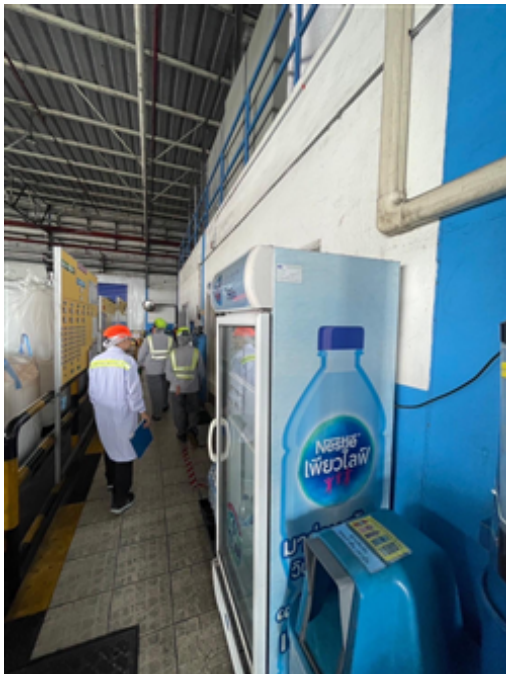
Drinking water provision.JPG

1.3.8	<i>Levels of access and adequacy of WASH at the site shall be identified.</i>	  Yes
Comment	<p>The site has adequate arrangements to ensure access to safe drinking water, sanitation and hygiene (WASH) for all workers. Site is also using a self-assessment tool for evaluating access to water sanitation and hygiene (WASH) at workplace. It covers the workplace facilities related to water supply, sanitation and hygiene.</p> <p>Site has maintained separate toilets for males and females, and also evaluated the adequacy of number of toilets for each gender. There are 58 females and 217 males (total of three shifts) in the site. According to national regulations, the minimum number of toilets for female is 4, and for male is 6. Actual number for female is 20 and for male is 18.</p> <p>WASH assessment 2024 was conducted. This is conducted yearly. The scoring system was made by an internal team. The number of toilets is higher than in 2023.</p> <p>Drinking water provision area is listed.</p>

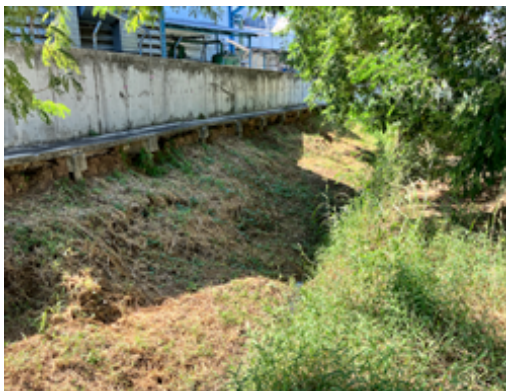
Klong Dan Canal (receiving water body).png

Comment	Water source locations are 4 deep wells within the site, and discharging point is Klong Dan Canal, adjacent to the site. They were visited during the audit.
