# CERTIFICATION REPORT

## Alliance for Water Stewardship (AWS)

Audit Number: AO-001292

Site: **BAT Turkey - Samsun**

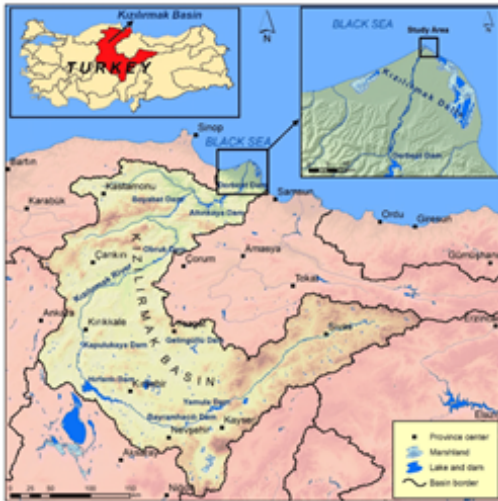
Kizilirmak Basini.png

The Kızılırmak Delta is located approximately 1 km from the factory site. Kızılırmak Delta has an area of 56,000 hectares, of which 12,000 hectares is in wetland regime. Having different habitats such as sea, river, lake, reeds, marsh, meadow, pasture, forest, dune and agricultural areas, the delta has a uniquely important biological diversity. On the eastern side, the open water area and marshy land is about 10,000 ha. On the western side, the lakes and the marsh-reed land around them are approximately 1,400 ha. The fact that it is one of the wetlands on the Black Sea coast that has partially preserved its natural character increases the importance of the delta even more. The natural habitats in the delta are the eastern wetlands where Liman, Balık, Uzun, Cernek, Gıcı and Tatlı lakes are located, and the western wetlands where Karaboğaz and Mülk Lake are located. Natural Protected Area and Wildlife Development Area are protected by protection status. Horhor Stream passes 1 km north of the factory site and Engiz Stream passes 840 m south.

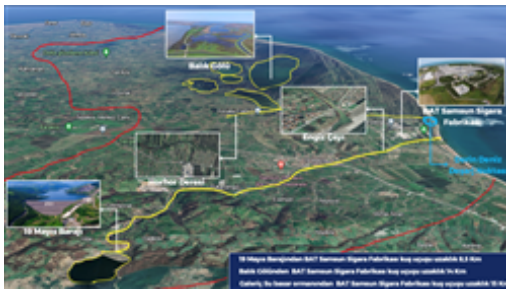
BAT\_physical\_scope.png

The Samsun factory, ranked 4th among BAT's 45 factories globally and 2nd in the Europe and North Africa (ENA) region, is located in the 19 Mayıs district of Samsun. The facility spans a total area of 520 decares and has a closed area of 136,000 square meters. The company manufactures cigarettes. All is manufactured and packed on site. Until April 2024, water for the facility was supplied from 4 wells and the SASKİ municipal network. Starting in April 2024, with SASKİ beginning to source water from the 19 Mayıs Dam, all water used at the facility is now supplied exclusively from the SASKİ network. The on-site water treatment plant at the facility is not operational, and all wastewater generated is sent to SASKİ's treatment plant.
