# CERTIFICATION REPORT

## Alliance for Water Stewardship (AWS)

Audit Number: AO-001652

Site: **Suzhou China Star Optoelectronics Display Co., Ltd**

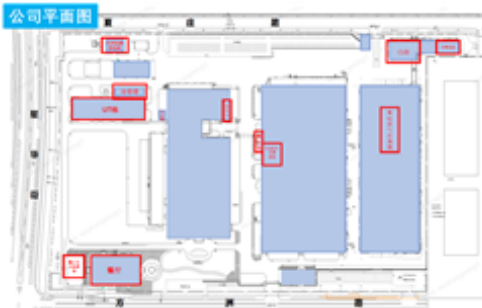
layout map of □□□□.png

Suzhou China Star Optoelectronics Display Co., Ltd. was established in 2002. The company is located at No. 318 Fangzhou Road, Suzhou Industrial Park, Jiangsu Province. It is a company engaged in the design, production, processing, and sales of liquid crystal displays and related products. The water supply for the site is entirely from the municipal water supply, provided by Qingyuan Huayan Xingang Street Water Plant, for both production and living purposes. The wastewater generated in the company's factory area includes both industrial wastewater and domestic sewage. The industrial wastewater mainly consists of backwash water from the pure water preparation system, RO concentrate, etc. There is no process wastewater generated at the site. The industrial wastewater is treated by neutralization and then discharged to the Qingyuan Huayan First Sewage Treatment Plant for further treatment. Domestic sewage is directly discharged into the municipal sewage network and then enters the Qingyuan Huayan First Sewage Treatment Plant for treatment, eventually being discharged into the Wusong River.
