# CERTIFICATION REPORT

## Alliance for Water Stewardship (AWS)

Audit Number: AO-001674

Site: **Abbott Laboratories (Pakistan) Ltd.**

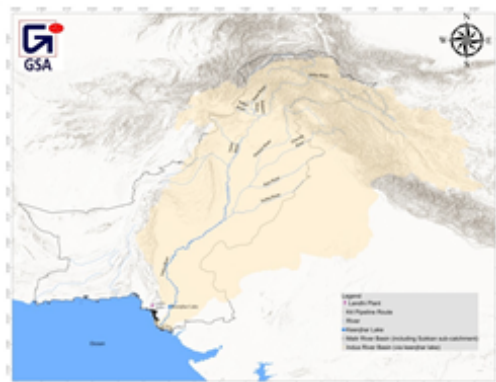
Indus River Basin (via Keenjhar Lake) Map.jpg

- Reduced snowmelt from the Himalayas, due to climate change, can lead to lower river flows.
- Irrigation withdrawals in Punjab and Sindh take up a large share of the river's flow before it reaches downstream users like Thatta and Karachi.
- Upstream dams and reservoirs, such as Tarbela and Mangla, regulate flow but can delay or reduce the volume of water released during dry seasons.
- In particularly dry years, Keenjhar Lake levels can fall significantly, leading to stress on Karachi's water supply.

Henceforth, while Keenjhar appears self-contained, it is deeply dependent on national water governance and seasonal availability within the greater Indus Basin.

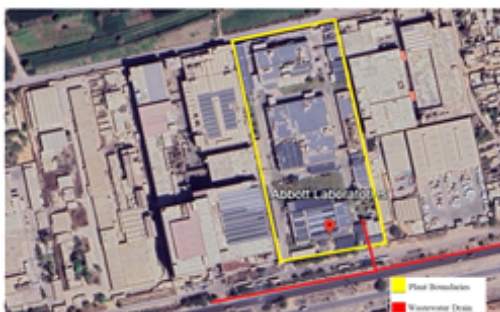
Site Boundries-Abbott Laboratories (Pakistan) Ltd.-Korangi Plant.jpg

-The Site's drainage (effluent and sewer) network layout and discharge point (of WWTP) were also available. WWTP inflow and outflow points are available.

The Site has two (2) wastewater streams namely effluent (process wastewater) and sewage (domestic wastewater). Wastewater generated on-Site is treated through the on-Site WWTP before discharging to the municipal drain Infrastructure through end-to-end pipeline network. Only a small level storm water drainage system which is collected in a rainwater pit and use in gardening finally drain in same discharge line if needed. The LP site has Approx. 1200 Employees with land area of 17 Acres whereas KP site has Approx 250 Employees with land area of 7 Acres.
