# CERTIFICATION REPORT

## Alliance for Water Stewardship (AWS)

Audit Number: AO-001747

Site: **Suntory Kyusyu Kumamoto Plant**

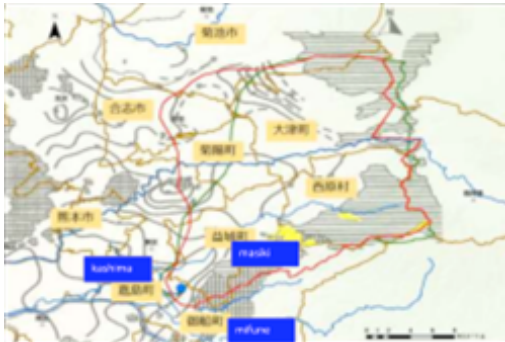
Suntory Kumamoto Catchment Map.png

The site relies only on groundwater, that's groundwater aquifer draining toward the Ariake Sea from the outer rim and foothills of Minamiaso, including the Mashiki, Nishihara, and Yamato areas. The surface water catchment is the Midorikawa River catchment.

The site draws groundwater from areas including Mashiki, Nishihara, and Yamato, within the area from the Minamiaso outer rim and foothills to the Ariake Sea.

The discharged water flows from the Tensui River, where the outlet is located, to the Yakata River, Kiyama River, Kase River, and Midori River, before finally flowing into the Ariake Sea.

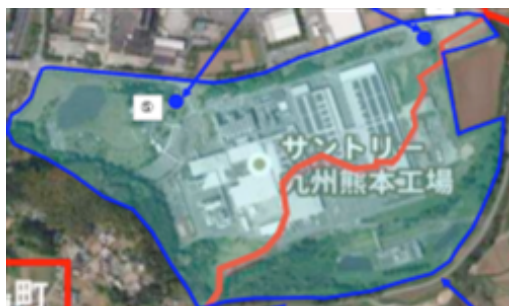
Kumamoto Plant Map.png

A short description of the site  
Completion year: 2003  
Site area: Approximately 400,000 m<sup>2</sup>  
Building area: Approximately 60,000 m<sup>2</sup>  
Number of employees: 262 people
