# CERTIFICATION REPORT

## Alliance for Water Stewardship (AWS)

Audit Number: AO-001743

Site: **BAT Uzbekistan - Samarkand Cigarette Factory**  
Address: 140100, Samarkand region, Farkhad settlement, 140100, Samarkand, UZBEKISTAN  
Contact Person: Alisher Mirtashev  
AWS Reference Number: AWS-000482  
Site Structure: Single Site

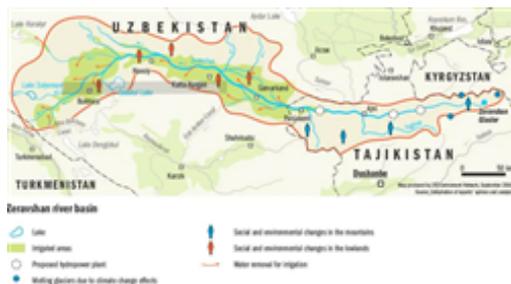
Catchment map (BAT Samarkand site).png

Catchment Name:  
Zarafshan River Catchment

The site is located in a groundwater transit zone formed by seepage losses from the right bank of the Zarafshan River.

Water scarcity area with seasonal shortages.

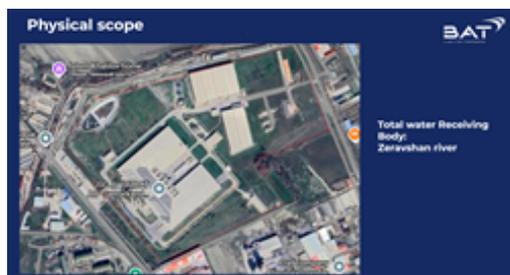
Site map (BAT Samarkand site).png

Water Infrastructure:

- 4 wells (2 active, 2 reserve).
- Reverse osmosis water treatment system.
- Complex wastewater treatment (physical, chemical, biological) with optional RO treatment.
- Cooling tower for compressors.
- Rainwater channels discharge to a pond.

Discharge: Process water goes to WWTP; RO reject water goes to pond; treated water is reused for toilets and cooling towers.

Site Size & Workforce: ~380 employees; site area 253,968 m<sup>2</sup>; building area 55,660 m<sup>2</sup>.
