CERTIFICATION REPORT

Alliance for Water Stewardship (AWS)

Audit Number: AO-001742

Site: **BAT Uzbekistan Urgut GLT**
Address: 141600, Samarkand region, Urgut city, 10 Navoi Shoh street, 141600, Urgut, UZBEKISTAN
Contact Person: Alisher Mirtashev
AWS Reference Number: AWS-000483
Site Structure: Single Site

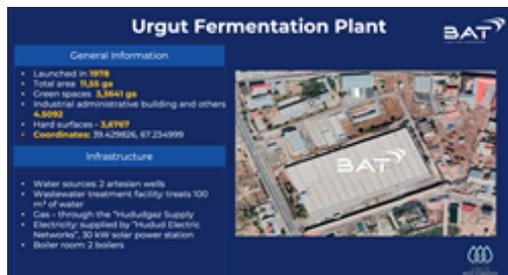
The site map(BAT - Urgut).png

Describe the Water-Related Infrastructure

- Water Sources: Two on-site wells (boreholes, approx. 190 m deep).
- Water Treatment Facilities: Updated water treatment facilities.
- Water Use for Production: Boilers and humidification processes.
- Water Use in Energy Facilities: Boilers for steam generation.
- Wastewater Treatment Facilities: Complex treatment using physical, chemical, and biological methods, with optional reverse osmosis.
- Rainwater Harvesting Infrastructure: Rainwater channels across the site direct water to a storage pond.
- Stormwater Management Infrastructure: Stormwater flows into the same pond-evaporator.
- Fire Water: Sprinkler systems installed.
- Other: Closed water system for internal use and irrigation. Treated water can be discharged to the municipal water treatment.

All process water is treated at the on-site wastewater treatment plant and then reused for irrigation. Treated water can be discharged to the municipal water treatment.

Stormwater is directed to the storage pond-evaporator.
