# CERTIFICATION REPORT

## Alliance for Water Stewardship (AWS)

Audit Number: AO-001822

Site: **Reyes Coca-Cola Bottling, San Leandro**

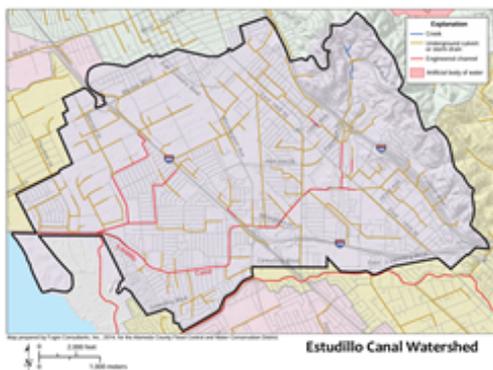
rccbsl catchment.png

The City of San Leandro is located in a low-lying area adjacent to the San Francisco Bay, known as the East Bay Plain. The watershed is the Estudillo Canal watershed. The area is bordered to the east by the Hayward Hills, and, in general, it is part of the Coast Ranges of California. The City of San Leandro has a Warm-Summer Mediterranean Climate, defined as Köppen Class Csb to Csc. The mean annual rainfall in the area since 2000 is approximately 495 mm (19.5 inches). Most precipitation occurs during the winter months (November through March). Source waters for the Plant in the Sierra Nevada mountain range have received an average annual precipitation of 59.20 inches since 1991.

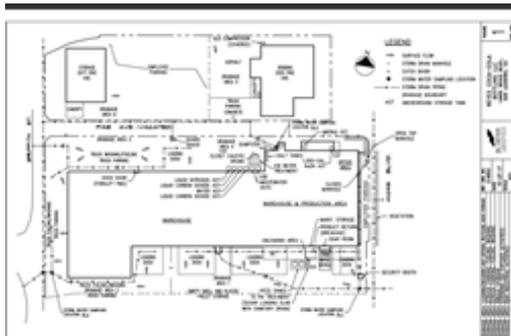
site plan.png

The plant (SLPC) is located at 14655 Wicks Boulevard, San Leandro, Alameda County, California, US. The SLPC is in an industrial area in the southwestern portion of the City of San Leandro, south of the City of Oakland and east of the San Francisco Bay. The site comprises a beverage production facility and warehouse space.

RCCB's SPLC covers approximately 11 acres and abuts the surrounding sidewalks and streets. The plant has five production lines with on-site blow molding. There are three can lines and two PET lines. The plant employs 400 people and runs three shifts, six days per week.
