CERTIFICATION REPORT

Alliance for Water Stewardship (AWS)

Audit Number: AO-001900

Site: **Victory Giant Technology (Huizhou) Co., Ltd.**

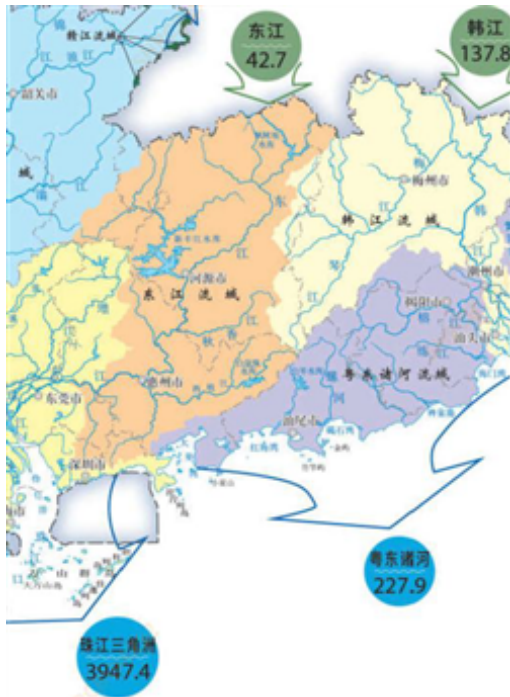
catchment map-1.png

The site is located in Huiyang District, Huizhou City, which belongs to Dongjiang River Catchment.

The site uses the tap water only from Huiyang municipal water plant. The plant abstracts the water from Dongjiang River Basin.

The wastewater is also discharged into Dongjiang River Basin after treated by the Yingzhihuang municipal wastewater treatment plant.

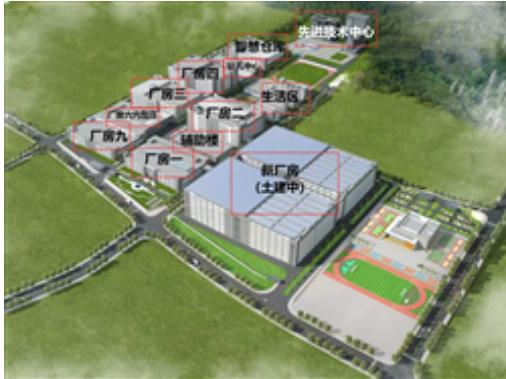
site map.jpg

The site is in an industry park, which surrounded by other factories. There is a school not far south of the factory, some community buildings are located south of the factory.

The site has two onsite waste water treatment system, and one reclaimed water reuse system. The waste water from industrial process is treated by onsite WWTP first, then discharge to municipal WWTP with domestic waste water for further treatment. Rainwater will discharge to Dan'ao river directly.
